Barrier Removal Action Plan City Hall Grounds

**FOR STAFF REVIEW
D1 - December 2017**

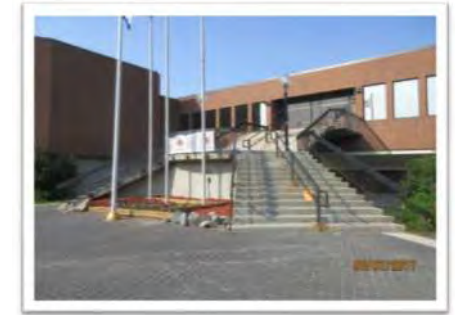
SECTION A: EXTERIOR ENVIRONMENTS

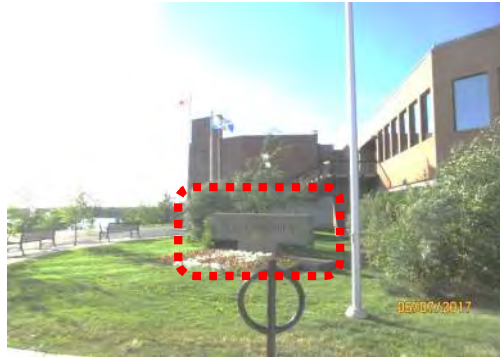
A1 Colour / tonal contrast is limited for exterior signage, which is also setback from main pedestrian routes.

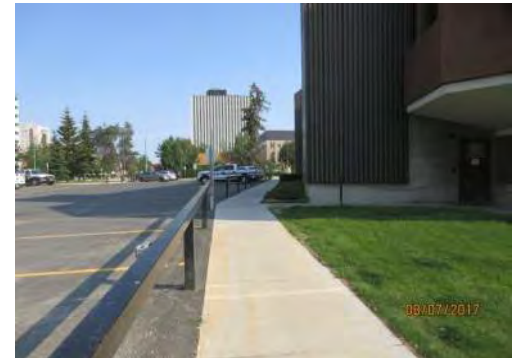
A12 Accessible walkway (east side of site). Surface is in very good condition and is well maintained. No problems were identified.

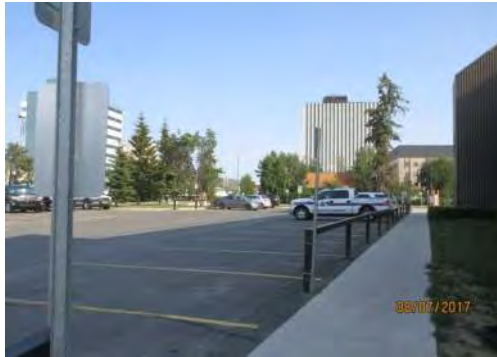
A13 View of staff parking lot (east side of site): No accessible parking spaces are provided.

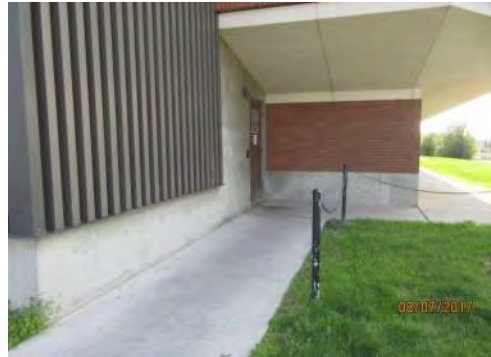
A14 Approach to rear staff entrance / exit (north east side of site). No problems were identified. Chains mounted between posts are not cane detectable for users with vision loss and may result in potential bumping / tripping hazards.

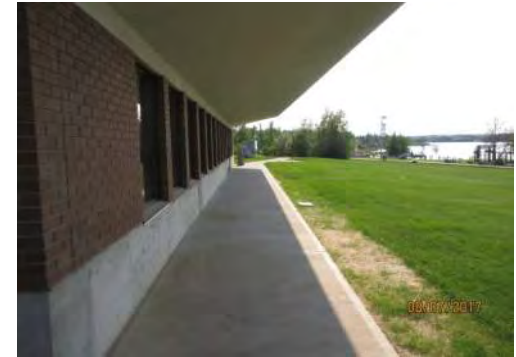
A15 Accessible walkway (view from north east side of site) is in very good condition and surface is well maintained. No problems were identified.

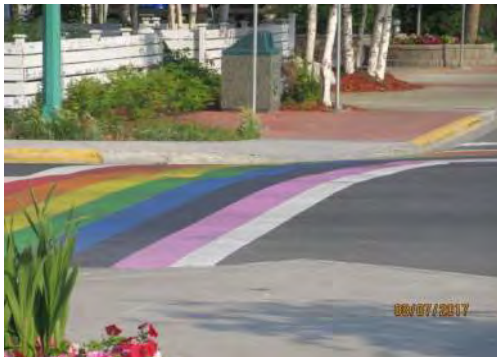
A16 No tactile walking surface indicators typically provided at curb ramps at pedestrian crosswalks.

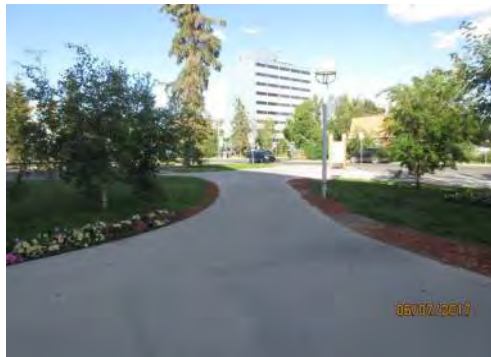
A17 Accessible walkway, to accessible entrance (south side), is in very good condition and surface is well maintained. No problems were identified.

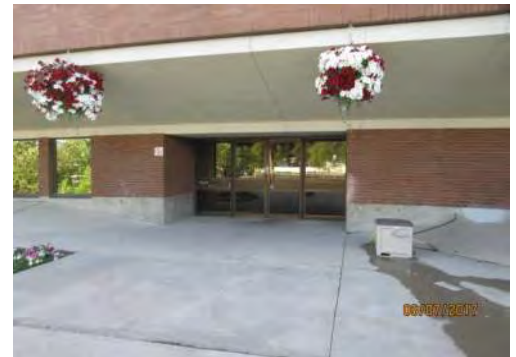
A18 Accessible walkway, to accessible entrance (south side), is in very good condition and surface is well maintained. No problems were identified.

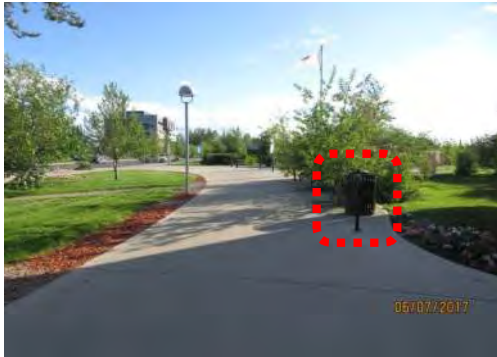
A19 Typical exterior waste receptacle is accessible for users of mobility aids (e.g., open top height for use). Black colour contrasts well with surroundings.

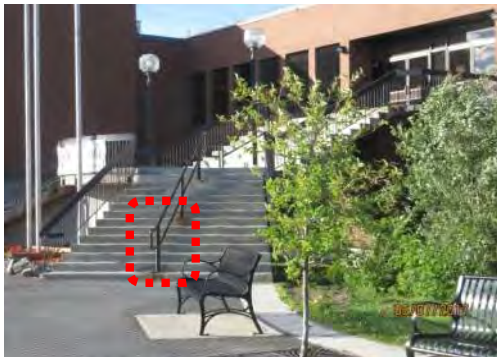
A22 View of staircase to main entrance which is not accessible. Handrail design is dated and not fully accessible. Stair tread and riser surfaces are in disrepair and rusting of handrails was evident at some locations.

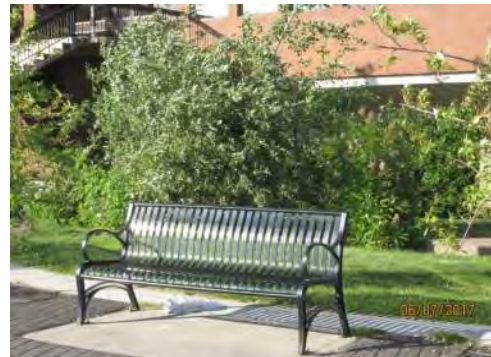
A23 Typical exterior bench seating is accessible. Adjacent clear space on at least one side of benches is not consistently provided.

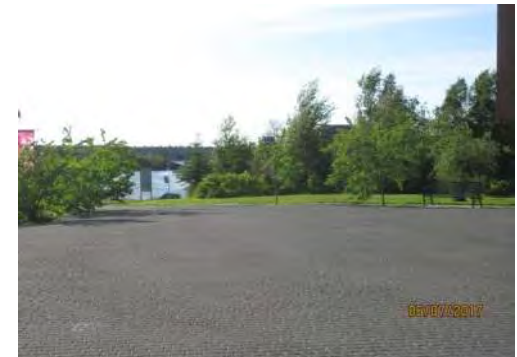
A24 Approach to waterfront, west side of site. Stamped concrete / brick paver surface is generally in very good condition.

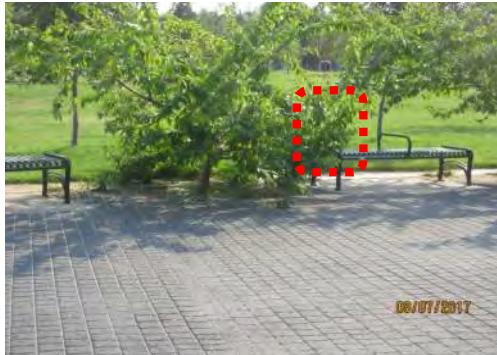
A25 Some bench seating is not accessible, with no back support and adjacent clear space provided on at least one side (e.g., for transfers). Some vegetation also requires maintenance where it obstructs use of bench.

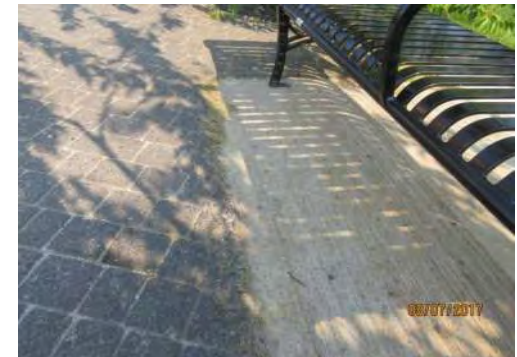
A36 Transition between edge of concrete and brick paver surfaces is uneven and sloped, which results in potential tripping hazard.

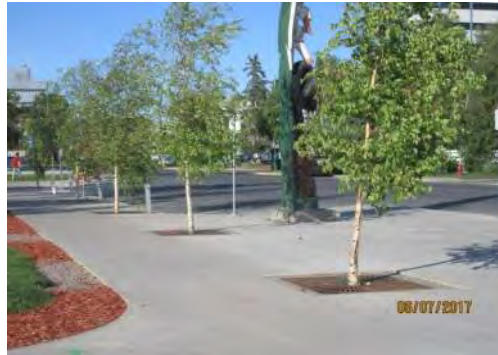
A37 Generally, public sidewalks are well maintained, with surfaces in excellent condition. Suitable gratings are typically provided. Colour contrast appears to have faded for some grates.

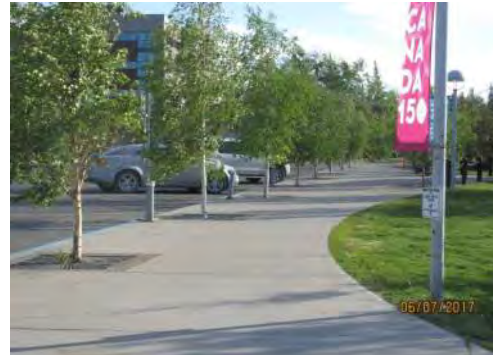
A38 Generally, public sidewalks are well maintained, with surfaces in excellent condition. Suitable gratings are typically provided. Colour contrast appears to have faded for some grates.

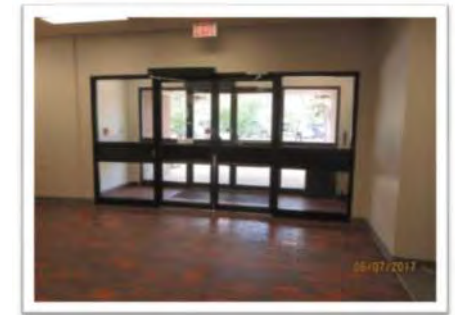
SECTION B: INTERIOR ENVIRONMENTS

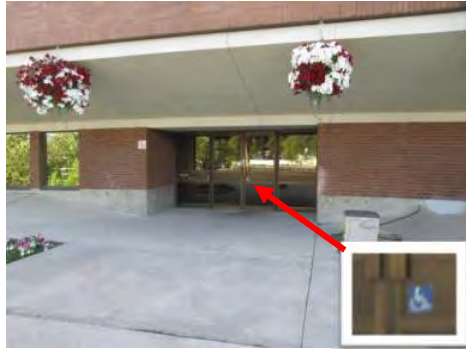
B1 Approach to accessible entrance (south side). Exterior accessible door is marked with International Symbol of Accessibility, but interior doors are not.

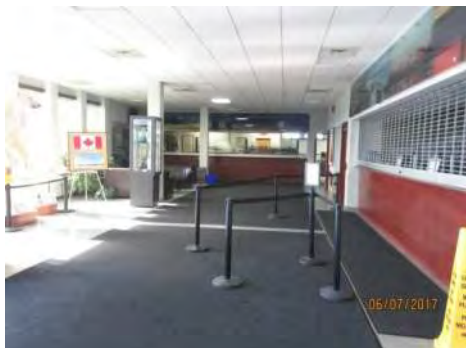
B22 2nd floor, entrance lobby: Line up guides do not have cane detectable lower edge which may result in bumping / tripping hazard for users with a vision loss.

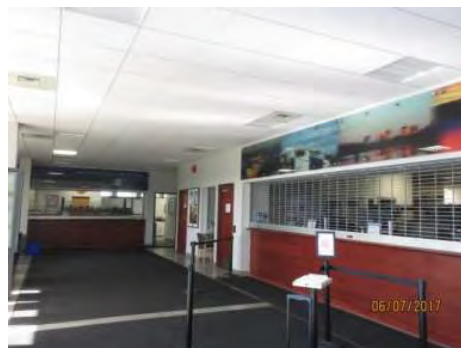
B23 2nd floor, Customer Service Counter. A lowered, accessible counter is provided adjacent to stand-up counter but may be difficult to identify.

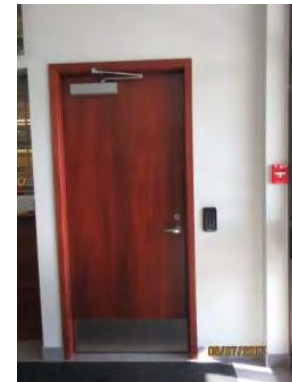
B30 Doors & Doorways: Clear door width is suitable for existing condition. Lever door hardware is accessible.

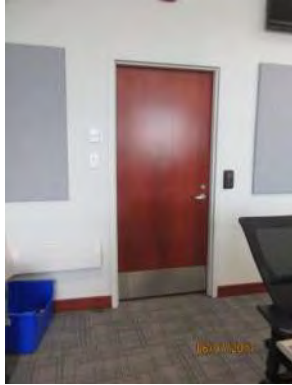
B31 Council Chamber, Entrance to Mayor's Executive Offices (2nd floor): Clear door width is suitable for existing condition. Lever door hardware is accessible.

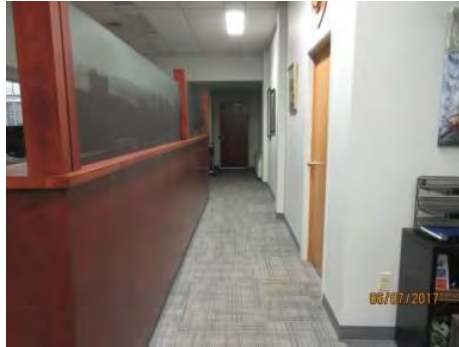
B32 2nd floor, interior circulation, Mayor's & Executive Offices: View of corridor.

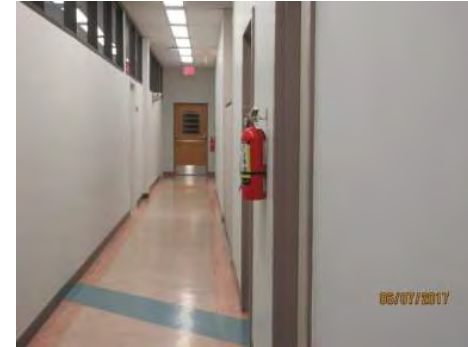
B33 2nd floor, Mayor's & Executive Offices, interior circulation: Generally, suitable clear width provided along central corridors. Base of fire extinguisher is not cane detectable for users with vision loss and extinguisher is a bumping hazard.

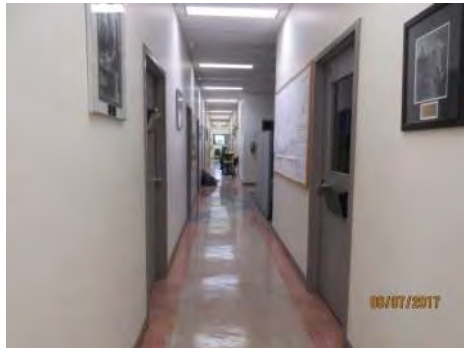
B34 2nd floor, interior circulation, Mayor's & Executive Offices: View of corridor. Some glare (a problem for users with vision loss) appears to be reflected off vinyl floor surfaces but is generally minor.

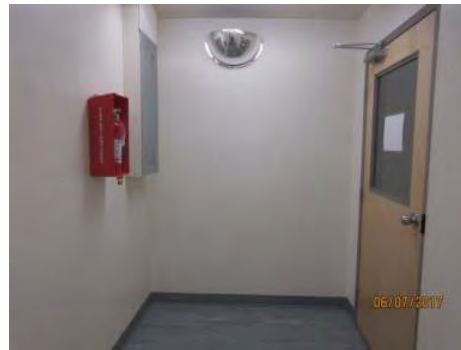
B59 Main floor, corridor (adj. to Office #118): Fire extinguisher projects from wall and is a potential bumping hazard.

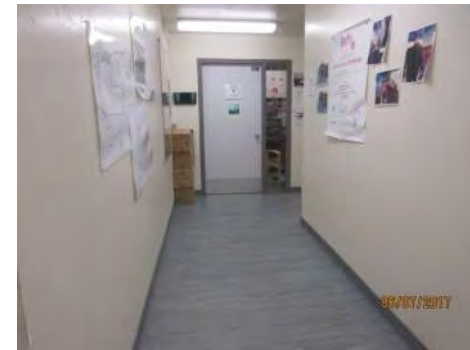
B60 Main floor, corridor (adj. to Office #118): Suitable clear width is provided.

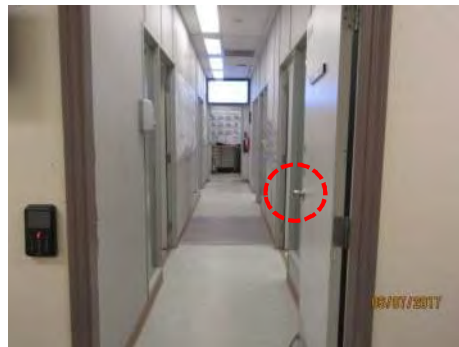
B62 Main floor, Entrance #121A to IT/Systems: Door clear width is suitable for existing condition. Knob door hardware is not accessible. Security control is suitably mounted.

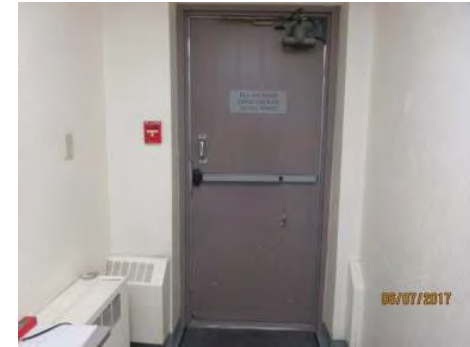
B63 Exit door, main floor (north west side): Door is recessed and approach to clear wall space at latch side of door is obstructed due to radiator.

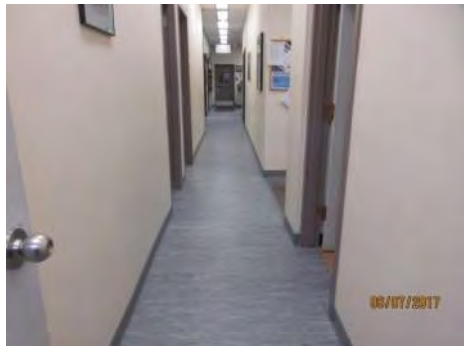
B64 Main floor, Entrance #106 to PW / Community Services / HR: Door clear width is suitable for existing condition. Knob door hardware is not accessible.

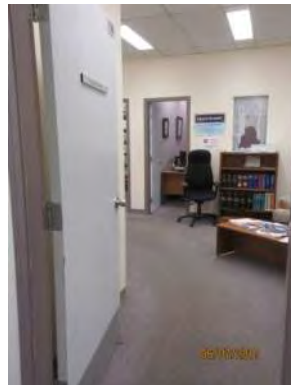
B65 Main floor, Entrance to Human Resources (Room #129): Suitable clear width is provided, however knob door hardware is not accessible.

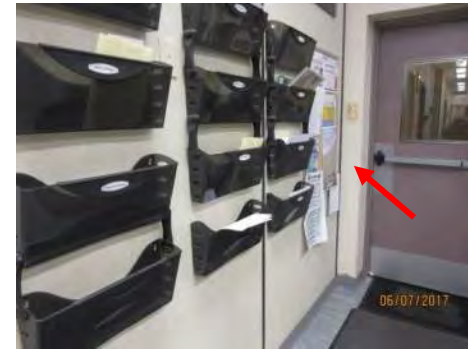
B75 Entrance to Stair #1 (interior door, northeast side): Clear door width is suitable for existing condition. Bottom edge of door glazing is mounted too high. Required clear wall space at latch side of door is not provided. (Note: Level access to exterior is not provided at this exit stair due to high transition)

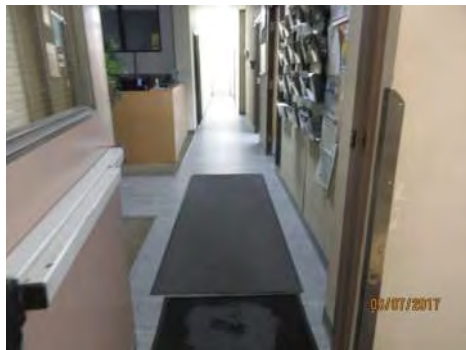
B76 Stair #1 (northeast side): Clear door width is suitable. Door glazing is mounted too high (bottom edge).

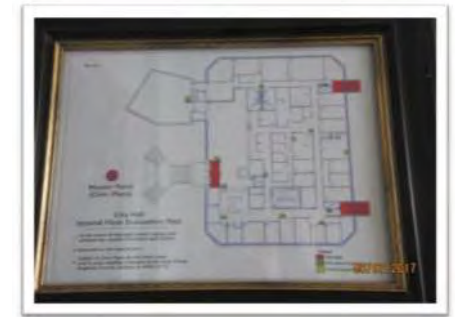
SECTION C: BUILDING SYSTEMS, CONTROLS & COMMUNICATIONS

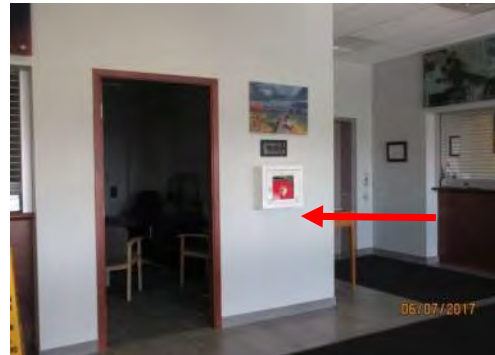
C8 AED Cabinet: Bottom edge is not cane detectable for users with a vision loss, therefore projection from wall is a potential bumping hazard.

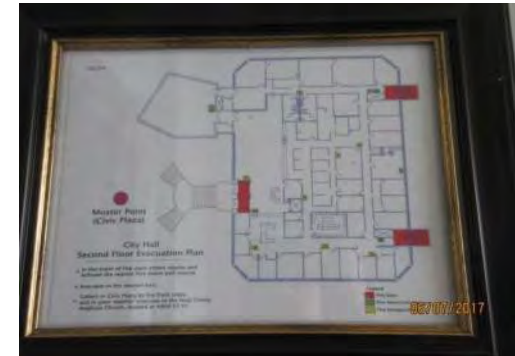
C9 2nd floor evacuation plan: No information related to accessible evacuation routes or information.

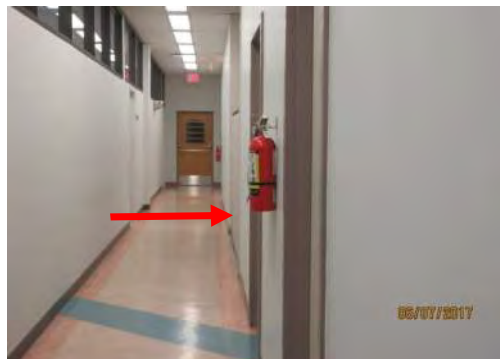
C10 2nd floor corridor: Fire extinguishers project from wall and are a potential bumping hazard with base not mounted at cane detectable height.

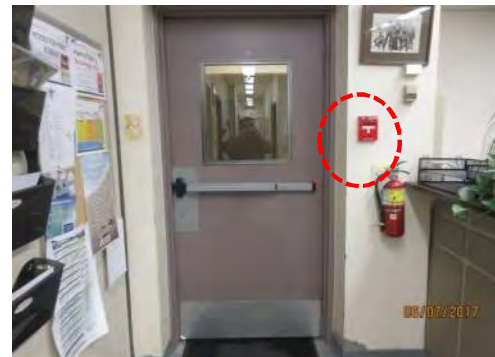
C11 Exit, main floor (south east side): Typical fire pull stations are mounted too high.

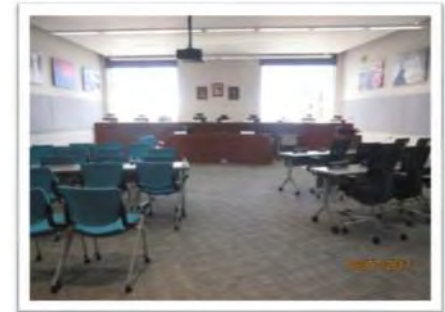
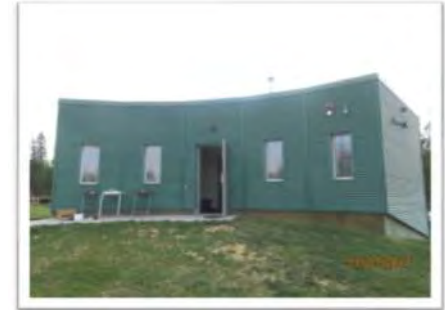
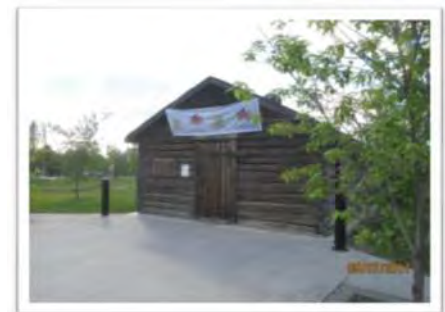
The following summary observations were made at the time of the audit:

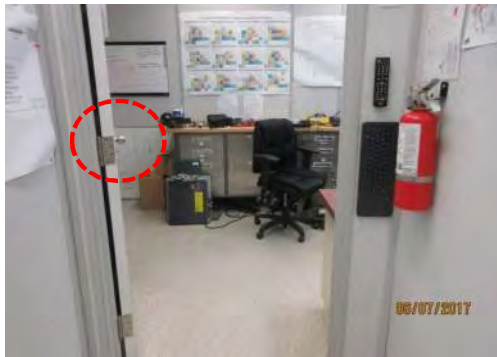
D31 Staff Office, Room #121A, main floor: Door clear width is suitable for existing condition. Knob door hardware is not accessible.

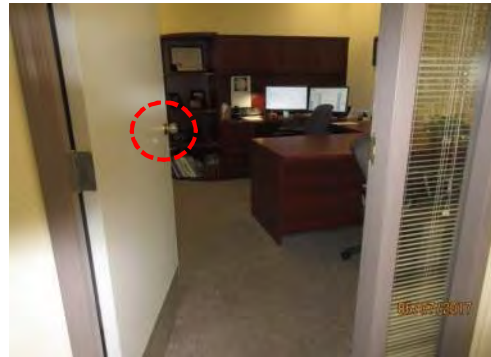
D32 Staff Office, main floor (rear of building): Door clear width is suitable for existing condition. Knob door hardware is not accessible.

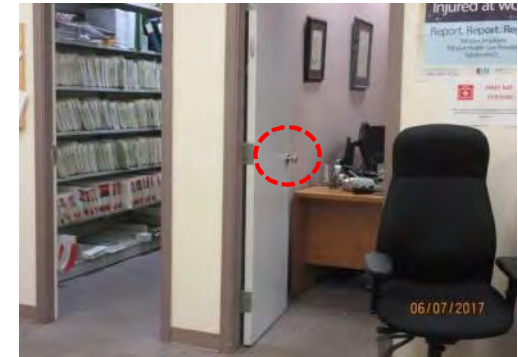
D33 Staff Office, Human Resources (Main Floor): Door clear width is suitable for existing condition. Knob door hardware is not accessible.

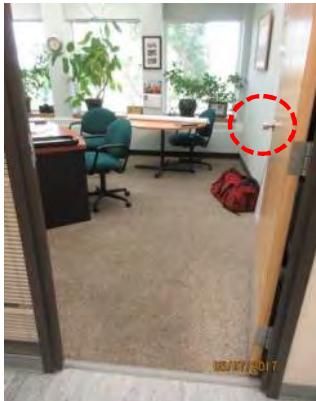
D34 Staff Office, Human Resources (Main Floor): Door clear width is suitable for existing condition. Knob door hardware is not accessible.

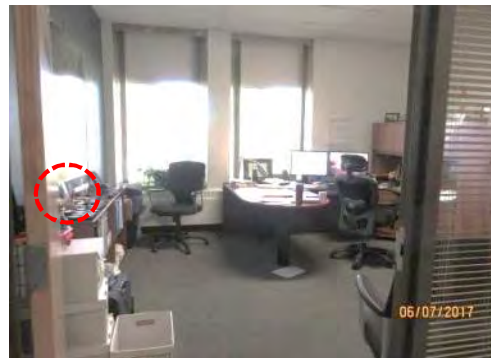
D35 Staff Office, Director of Community Services, Room #136 (Main Floor): Door clear width is suitable for existing condition. Knob door hardware is not accessible.

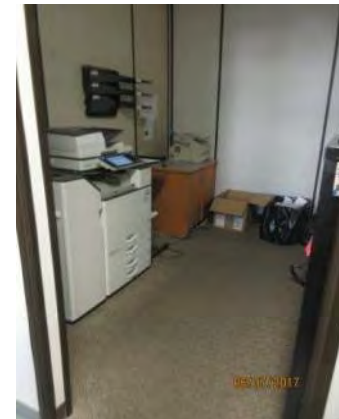
D36 Example of Staff Equipment Room (main floor): No door is provided. Generally, interior circulation for users of mobility aids is limited.

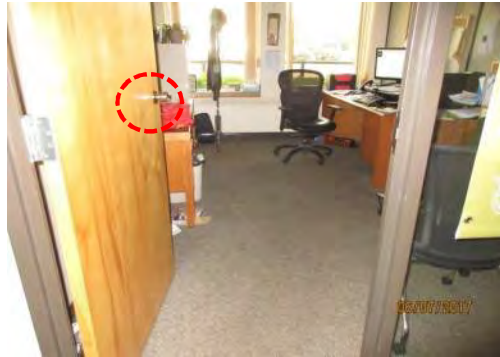
D37 Private Office, Main Floor (south side): Door clear width is suitable for existing condition. Knob door hardware is not accessible.

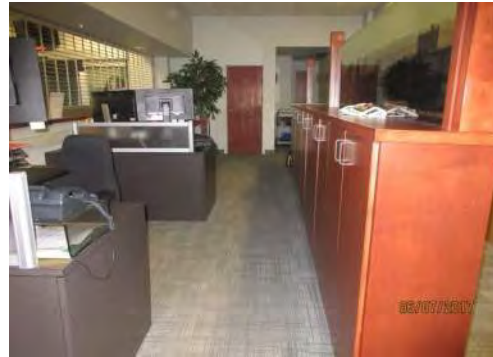
D38 Mayor's & Executive Offices, 2nd floor: Typical aisle space for circulation at staff work areas.

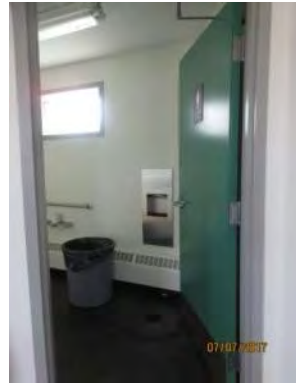
D92 Somba K'e Service Building (interior): Men's washroom is not accessible. Clear door width is limited but suitable for existing condition. Lever door hardware is provided. No power door operator is provided.

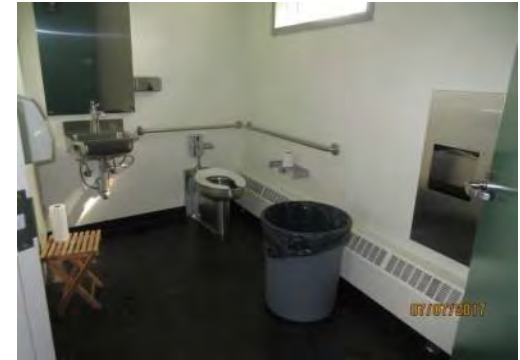
D93 Somba K'e Service Building (interior): Women's washroom is not accessible although some accessibility features are provided (e.g., grab bars). No transfer space is provided at side of toilet. Interior floor space is limited.

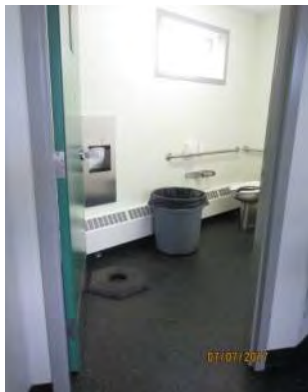
D94 Somba K'e Service Building (interior): Men's washroom is not accessible. Clear door width is limited but suitable for existing condition. Lever door hardware is provided. No power door operator is provided.

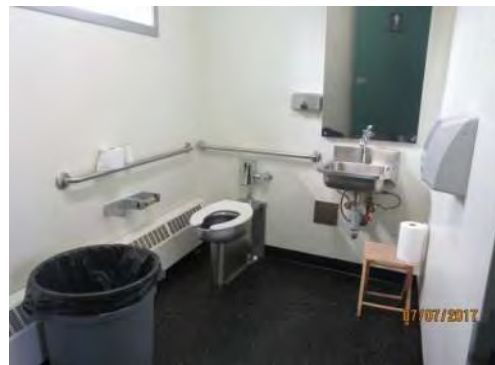
D95 Somba K'e Service Building (interior): Men's washroom is not accessible although some accessibility features are provided (e.g., grab bars). No transfer space is provided at side of toilet. Interior floor space is limited.

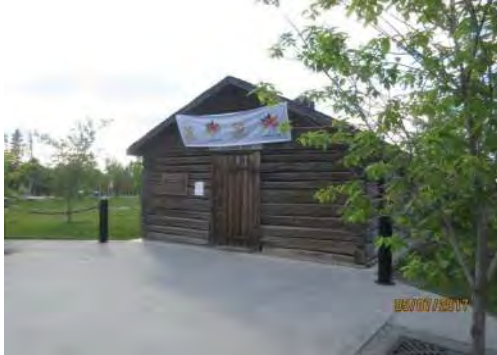
D97 Fireweed Studio (exterior): General view. Building identification signage above entrance is a "rustic" design and is not legible from a distance.

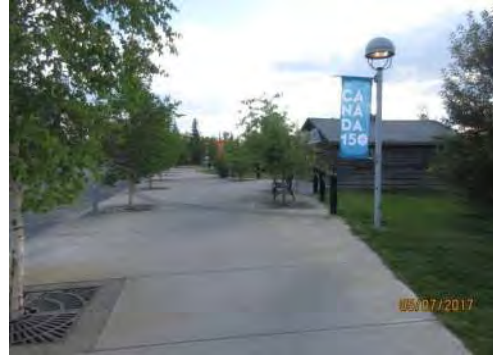
D98 Fireweed Studio (exterior): Ample clear width is provided along pedestrian sidewalk, leading to and from studio.

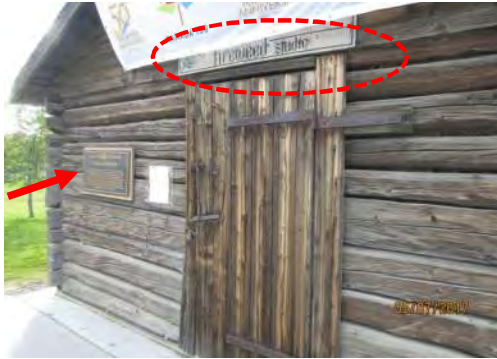
D103 Fireweed Studio (exterior): Building identification signage is "rustic" design, with no accessibility features. Interpretive plaque signage has limited to no accessibility features, mounted adjacent to entrance.

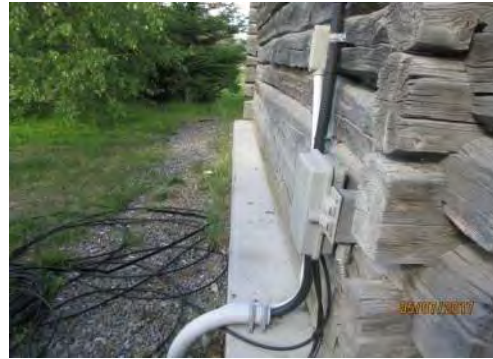
D104 Fireweed Studio (exterior): General view.

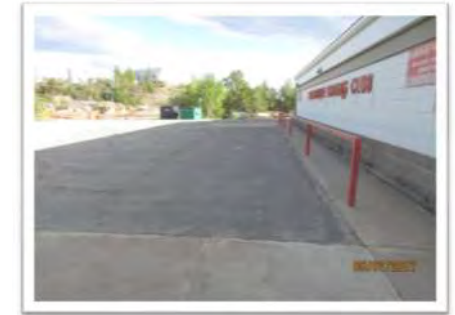
SECTION A: EXTERIOR ENVIRONMENTS

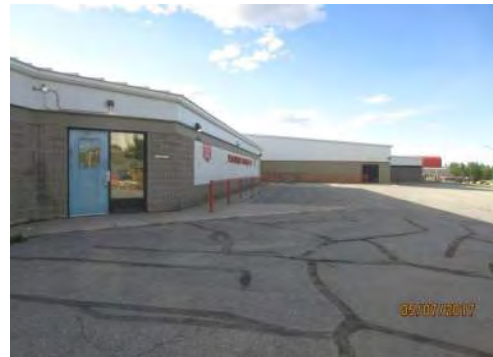
A5 View towards secondary entrance from parking lot. Asphalt appears to be in poor condition in some areas.

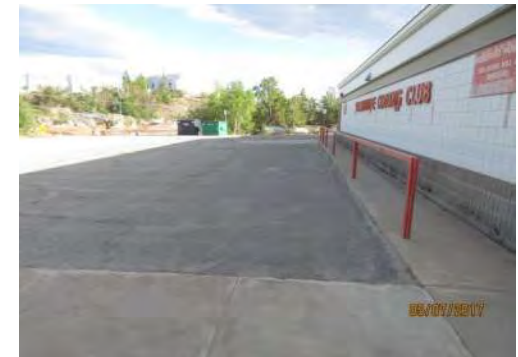
A6 Parking Lot: No spaces are marked. No accessible parking spaces are designated through pavement markings or signage.

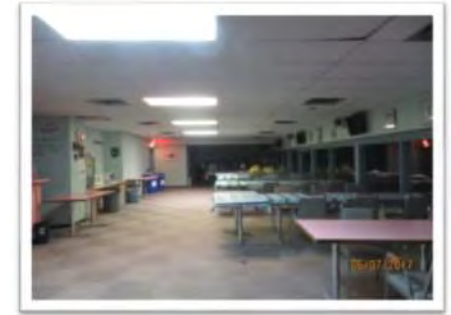
SECTION B: INTERIOR ENVIRONMENTS

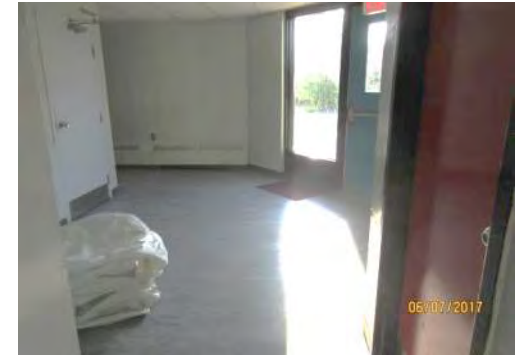
Circulation door leading to secondary entrance / exit (grade level).

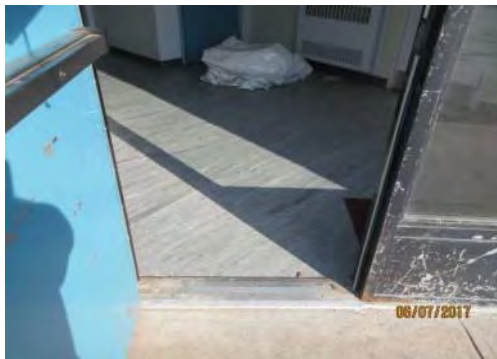
Secondary staff entrance / exit: Some glare observed.

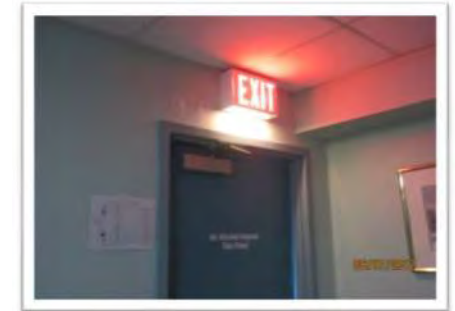
SECTION C: BUILDING SYSTEMS, CONTROLS & COMMUNICATIONS

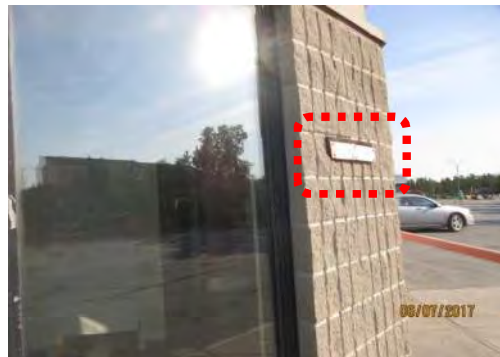
C4 Exterior entrance identification sign is worn / faded, with no accessibility features (e.g., large text / colour contrast etc.).

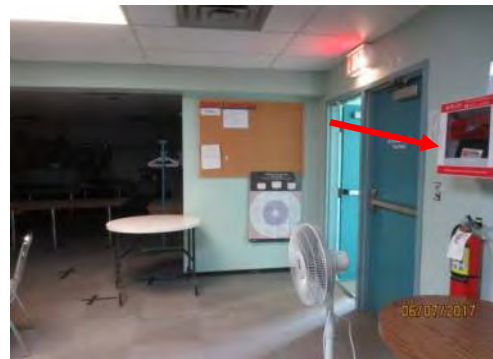
C5 AED Cabinet: Bottom edge is not cane detectable for users with a vision loss, therefore projection from wall is a potential bumping hazard for users with a vision loss.

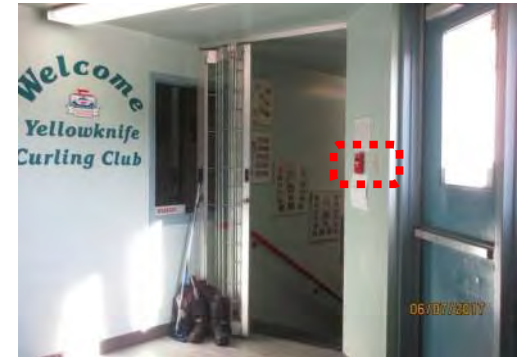
C6 Typical fire pull and light switch are mounted too high for users of mobility aids.

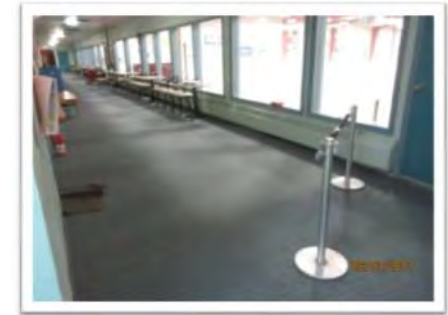
The following summary observations were made at the time of the audit:

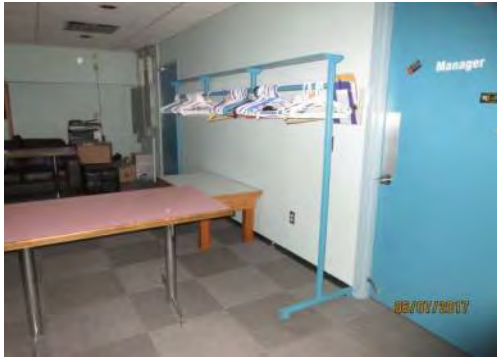
D1 Manager's Office (upper level): Door clear width and knob door hardware is not accessible.

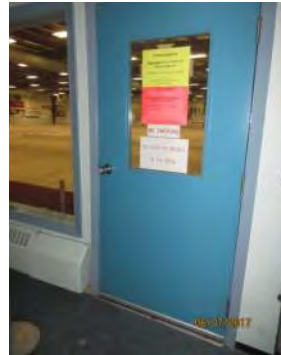
D8 Curling Rink (accessed from Lower Level): Level access at entry #1 and suitable clear door width is provided for an existing condition, however, no elevator access is provided to this level.

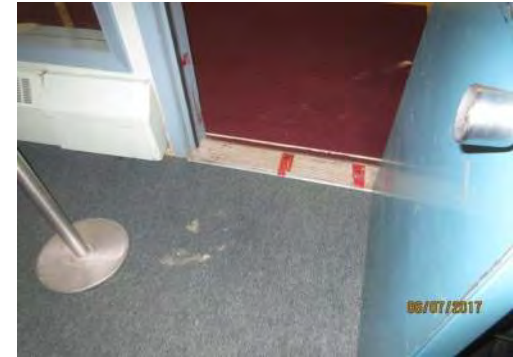
D9 Entrance, Curling Rink (accessed from Lower Level): Level access at entry #1 and suitable clear door width is provided for an existing condition, however, no elevator access is provided to this level.

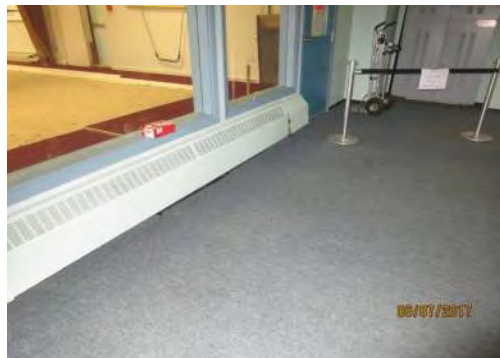
D10 Curling Rink Viewing Area (lower level): View of floor space provided.

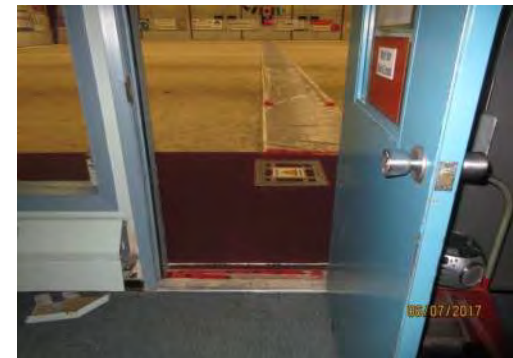
D12 Curling Rink (accessed from Lower Level): Level access at entry #2 and suitable clear door width is provided for an existing condition, however, no elevator access is provided to this level.

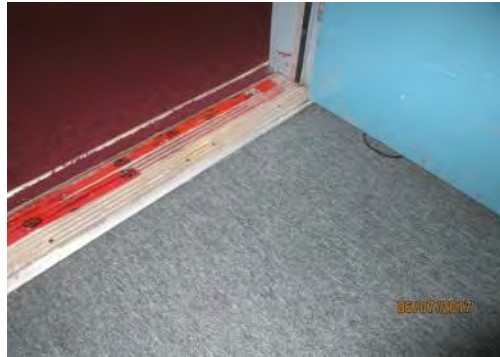
D13 Curling Rink (accessed from Lower Level): Level access at entry #2 and suitable clear door width is provided for an existing condition, however, no elevator access is provided to this level.

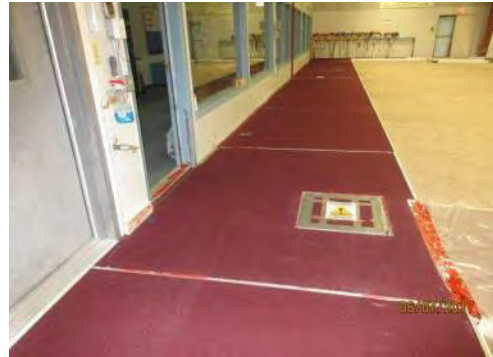
D14 Curling Rink (accessed from Lower Level): Entrance from viewing area and aisle at rear of ice surface.

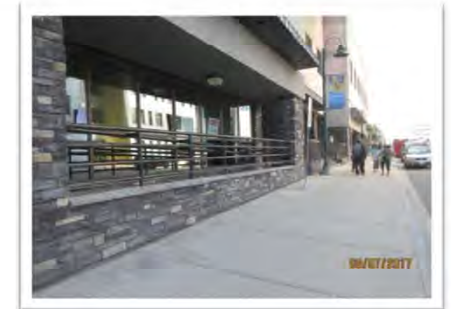
SECTION A: EXTERIOR ENVIRONMENTS

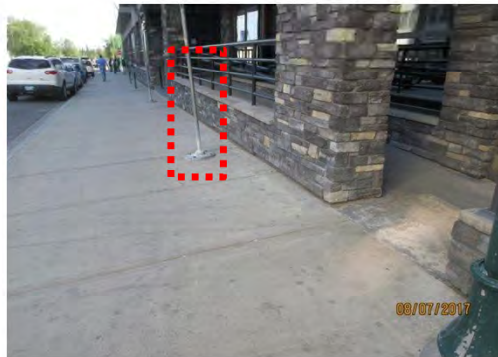
A4 Approach to ramp entry point, off of 49th street. Typical public sidewalk is well maintained and in very good condition. Post-mounted signage has limited colour contrast.

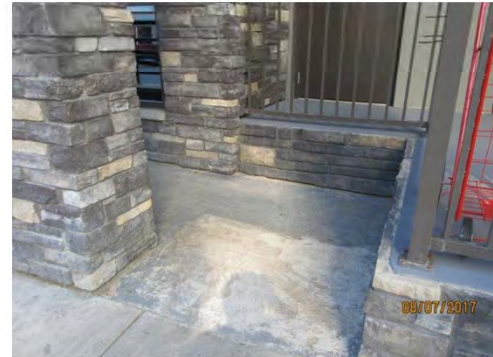
A5 Ramp entry (bottom landing): Surface is in disrepair. Clear width is too narrow and landing size is too small.

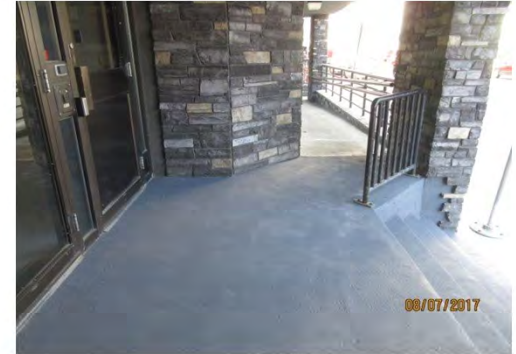
A15 View of top landing of stair and ramp. Landing is awkward configuration by door. Power door swings towards top landing of ramp which is a potential bumping hazard. No TWSI is provided at top of stair landing.

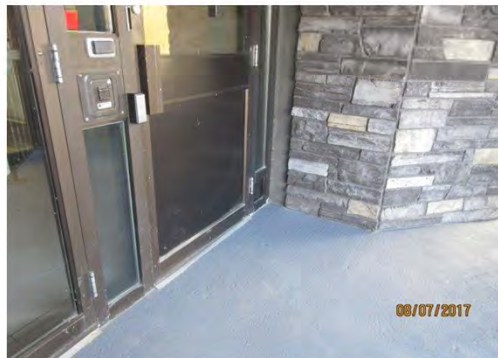
A16 View of top landing of stair and ramp. Landing depth is very limited. Power door swings towards top landing of ramp which is a potential bumping hazard.

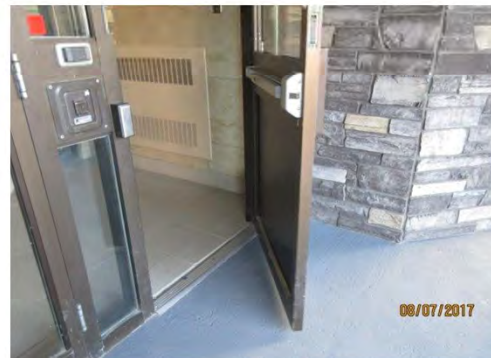
A17 View of top landing of stair and ramp. Landing depth is very limited. Power door swings towards top landing of ramp which is a potential bumping hazard.

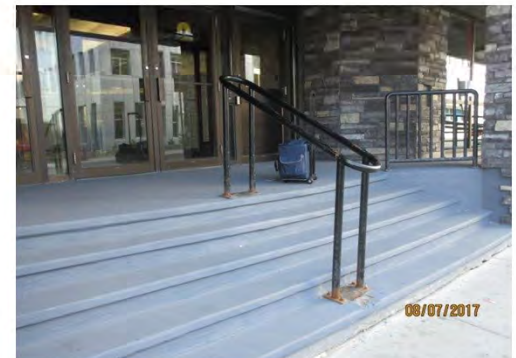
A18 Stairs: No colour contrasted nosings are provided. A centre handrail is provided only. No handrails are provided on other sides of stairs.

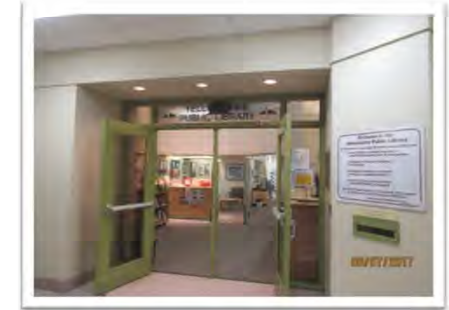
SECTION B: INTERIOR ENVIRONMENTS

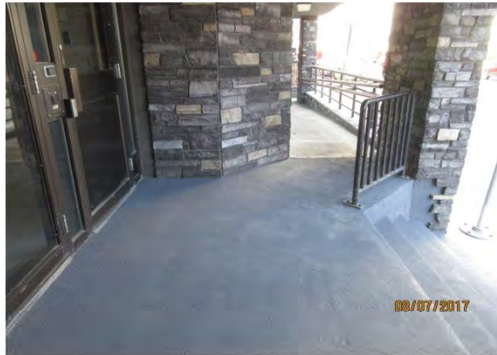
B1 Entrance (stair & ramp, 49th St.): Accessible entrance is not marked with ISA decal. Top landing of ramp is awkward configuration.

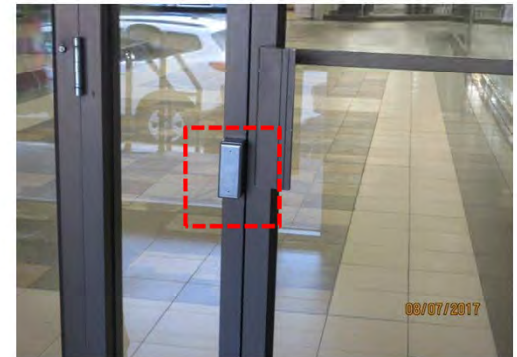
B6 Entrance (stair & ramp, 49th St.), interior side: Accessible entrance is not marked with ISA decal. A power door operator is provided, however, controls are too small and ISA symbol has faded. Adjacent door swings toward user and power door operator control and is potential bumping hazard.

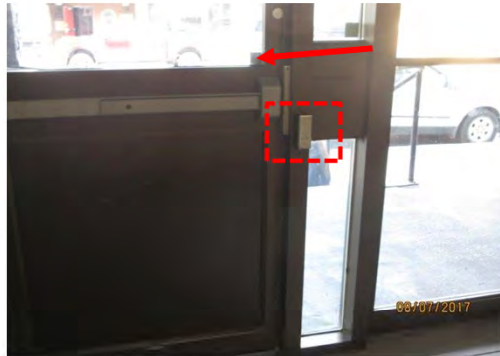
B7 Entrance (stair & ramp, 49th St.): Exterior door glazing is mounted too high. Power door operator control is too small.

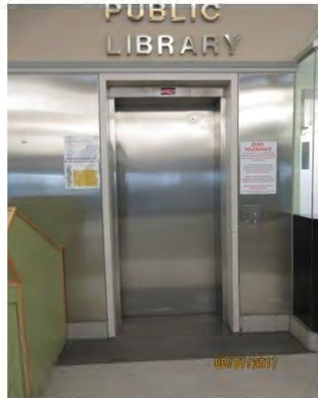
B13 View of Elevator lobby, off of mall, ground floor. Stainless steel surface, when highly polished, reflects glare which is a potential problem for users with vision loss.

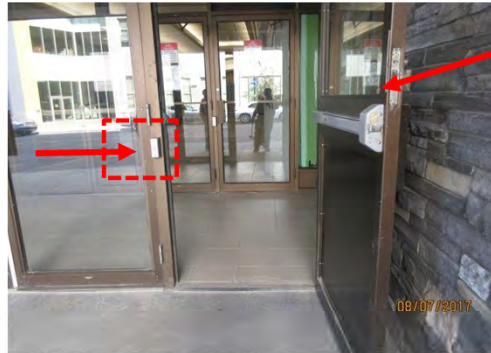
B14 Entrance (Sloped route), exterior vestibule door: Lower edge of glazing is too high. Clear width is suitable for existing. Exterior door is not marked with ISA decal.

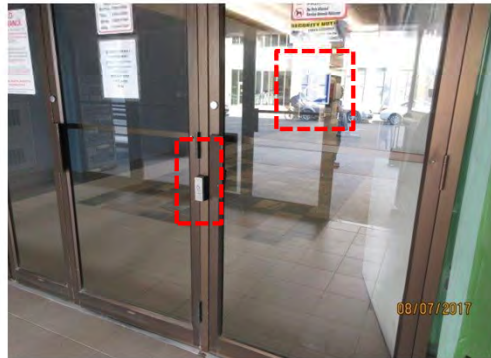
B17 Entrance (Sloped route), interior vestibule door: Door is marked with ISA decal. Power door operator control is small. Adjacent door swings toward user and power door operator control and is potential bumping hazard.

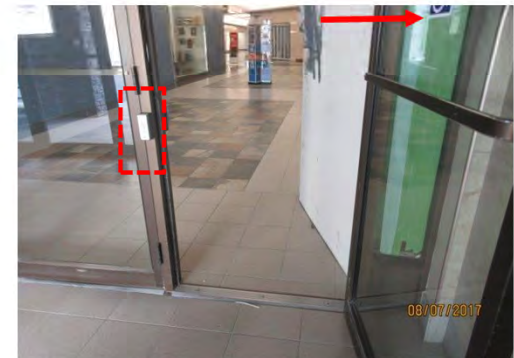
B18 Entrance (Sloped route), interior vestibule door: Level access is provided. Clear width and threshold is suitable. Interior door only is marked with ISA. Power door operator control is small.

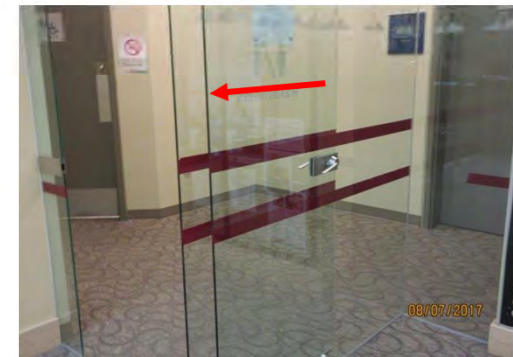
B54 Entry vestibule (washroom area): Edges of glazing are not clearing marked for users with vision loss, resulting in potential bumping hazards.

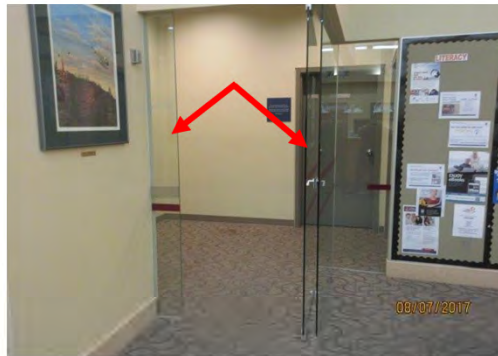
B55 Entry vestibule (washroom area): Clear door width is too narrow and non-compliant. Edges of glazing are not clearing marked for users with vision loss, resulting in potential bumping hazards.

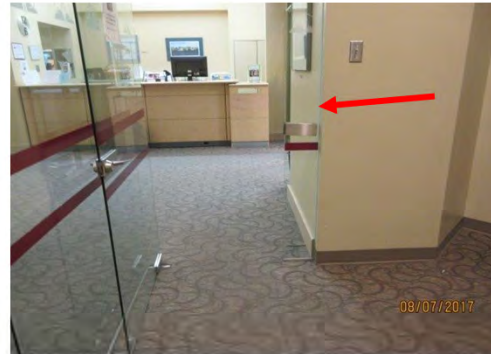
B56 Entry vestibule (washroom area): Edges of glazing are not clearing marked for users with vision loss, resulting in potential bumping hazards.

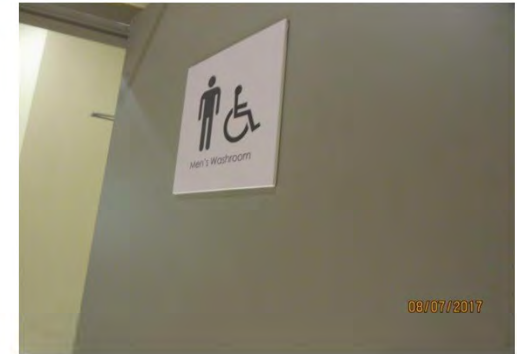
B57 Men's Accessible Washroom: Identification signage is not accessible, mounted on face of door. No braille / tactile features provided.

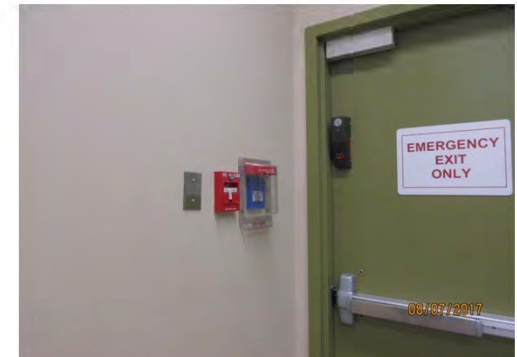
B78 Exit Stair (adj. to Meeting Room): Fire alarm pull is mounted too high. Appeared to be typical condition throughout.

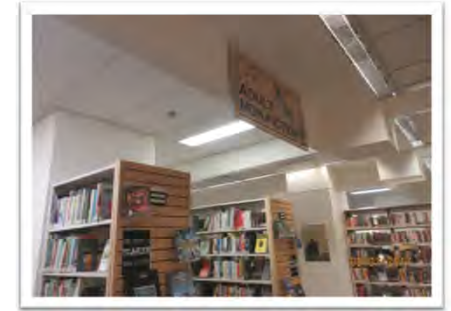
SECTION C: BUILDING SYSTEMS, CONTROLS & COMMUNICATIONS

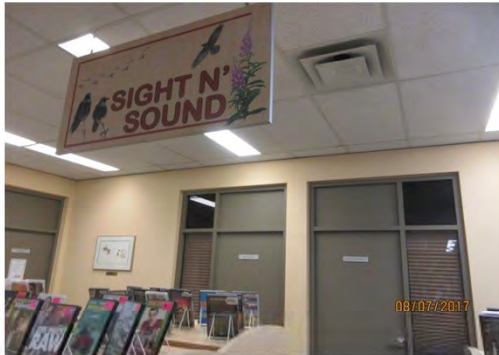
C1 Typical overhead collection / space identification signage.

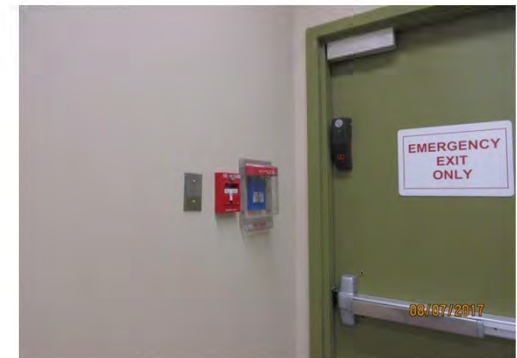
C18 Exit Stair (adj. to Meeting Room): Fire alarm pull is mounted too high. Appeared to be typical condition throughout.

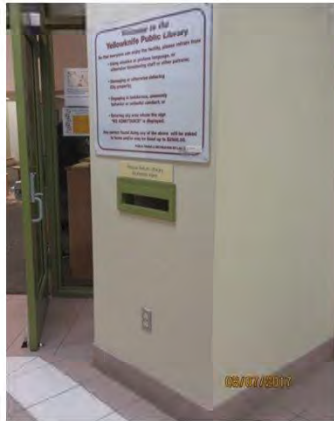
C19 Book Return and Information Signage: Suitable colour contrast is provided. Print size is typically small, with no braille / tactile features or alternate accessible signage provided.

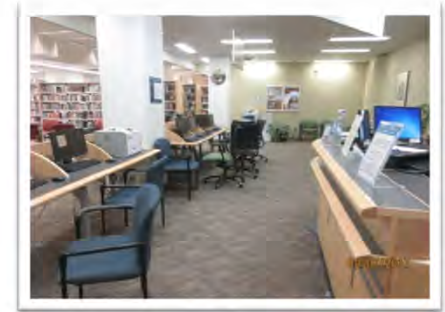
SECTION D: SPECIAL FACILITIES, SPACES & ENVIRONMENTS

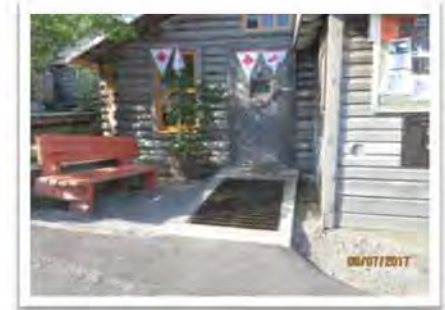
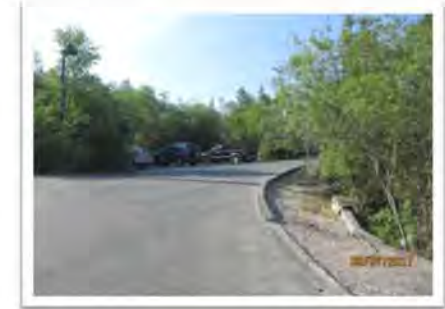
SECTION A: EXTERIOR ENVIRONMENTS

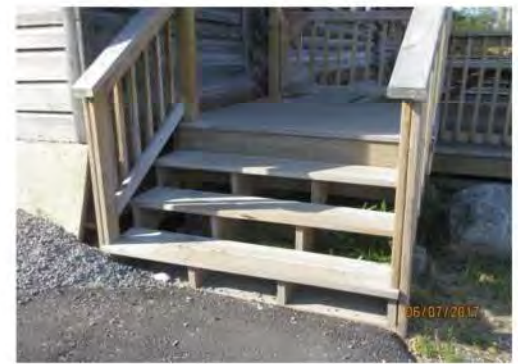
A12 Stair access only is provided to exterior deck. Open risers are potential tripping hazard. Handrails are oversized and difficult to grasp. Tread nosings are not high contrast.

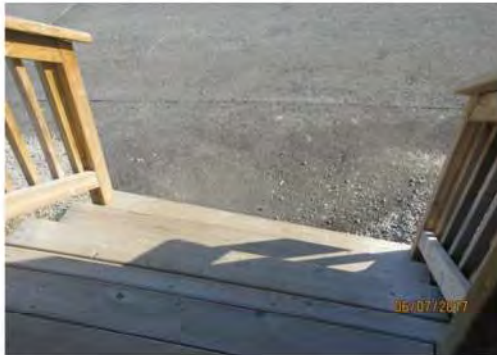
A13 Stepped access only is provided to exterior deck. No colour contrasted nosings are provided. Handrail is oversized.

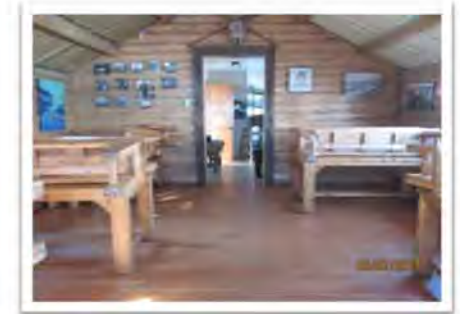
SECTION B: INTERIOR ENVIRONMENTS

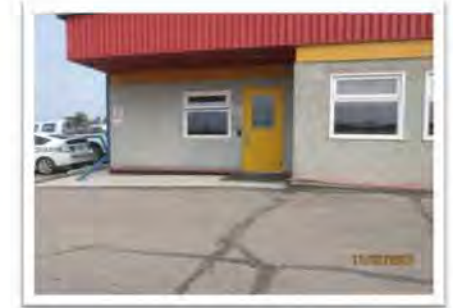
SECTION A: EXTERIOR ENVIRONMENTS

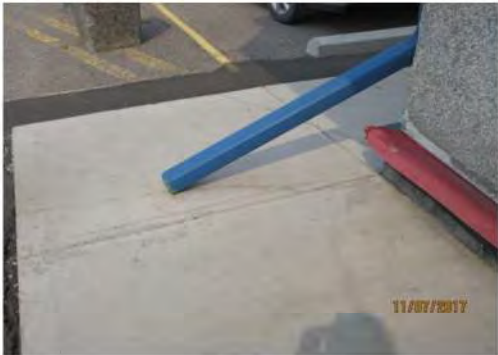
A20 Main entrance area: Eave trough obstructs clear width and is a potential tripping hazard.

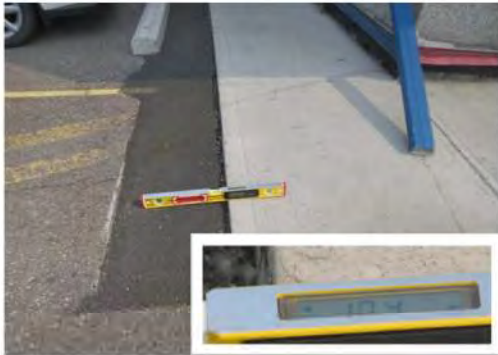
A21 Main entrance area: Considerable slope at transition between sidewalk and drive aisle at 10.4%.

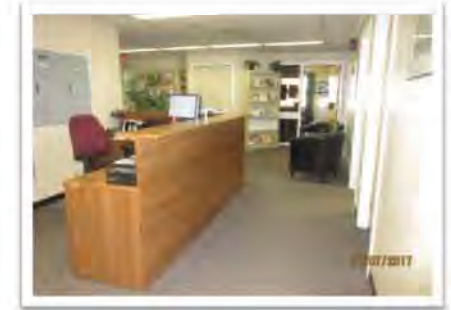
SECTION B: INTERIOR ENVIRONMENTS

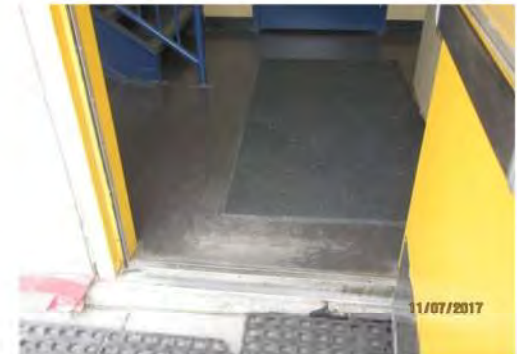
B3 Main entrance (north side): Transition is too high and entrance is not accessible. Clear door width is too narrow but suitable for an existing condition. Threshold ramp is in significant disrepair.

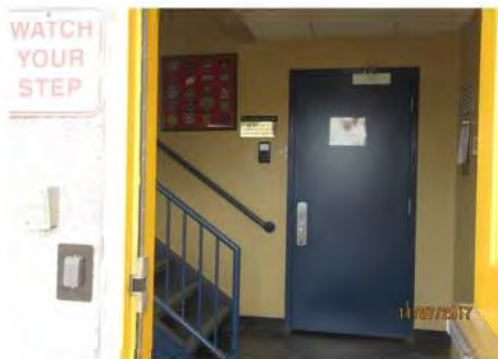
B4 Main entrance: View of interior vestibule and stair to 2nd floor.

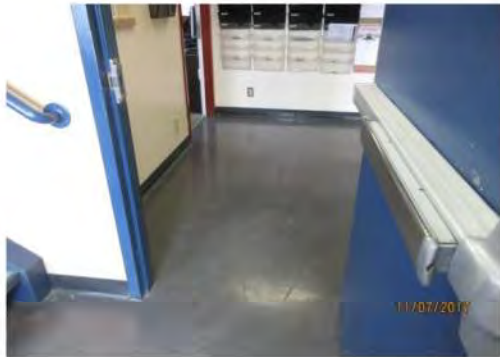
B21 1st floor, entrance vestibule (interior door): Clear width is too narrow but suitable for existing condition. Main entrance is not accessible for users of mobility aids.
