Barrier Removal Action Plan City Hall Grounds

**FOR STAFF REVIEW
D1 - December 2017**

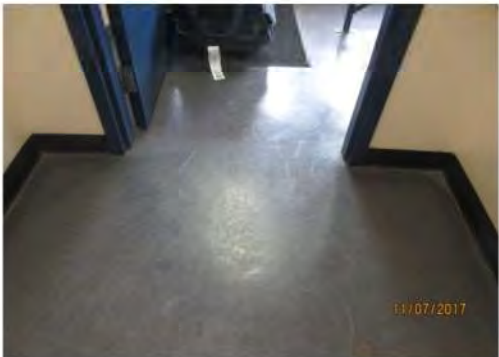
B22 1st floor, entrance vestibule (interior door): Clear width is too narrow but suitable for existing condition. Main entrance is not accessible for users of mobility aids.

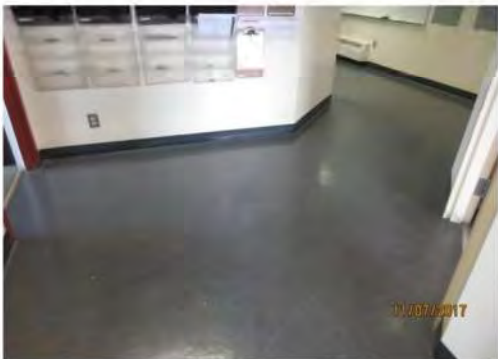
B23 1st floor, entrance vestibule: Circulation is suitable.

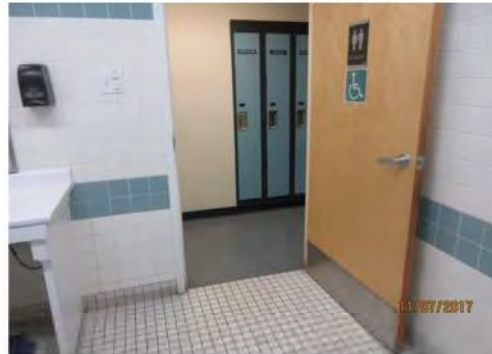
B38 1st floor, Unisex accessible washroom: Entrance clear width is suitable for existing condition. Lever door hardware is accessible.

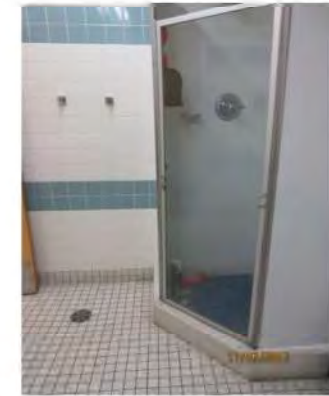
B39 1st floor, Unisex accessible washroom: Shower is not accessible due to stepped / curbed entry.

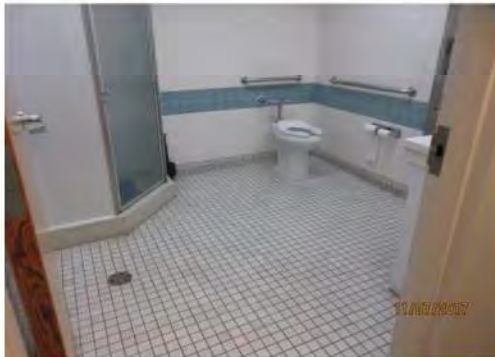
B40 1st floor, Unisex accessible washroom: Entrance clear width is suitable for existing condition. Interior floor space is suitable, including transfer space at side of toilet.

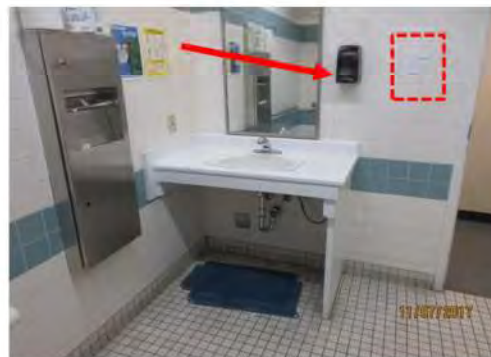
B41 1st floor, Unisex accessible washroom: Occupancy sensor provided. Lavatory & mirror are accessible. No pipe protection below. Soap dispenser is mounted too high. Paper towel dispenser is too high & operating control is not accessible.

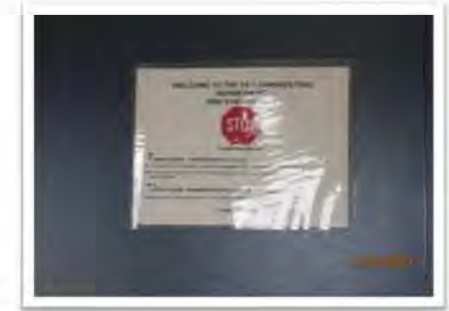
SECTION C: BUILDING SYSTEMS, CONTROLS & COMMUNICATIONS

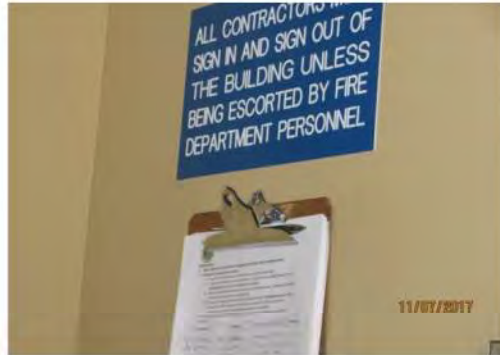
C1 Main entrance lobby, informational signage and sign-in clip-board: No accessibility features identified.

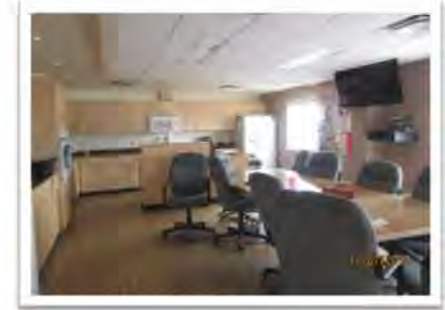
The following summary observations were made at the time of the audit:

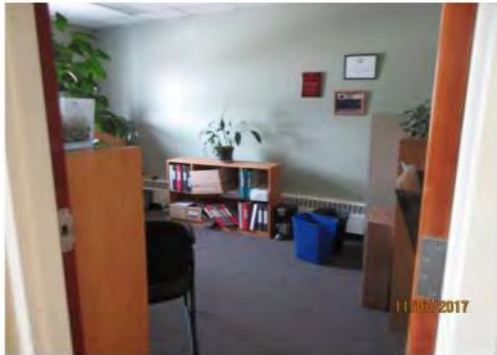
D1 2nd floor, Office (south east corner): Typical entrance has suitable clear width for an existing condition. No accessibility features identified. 2nd floor is not accessible.

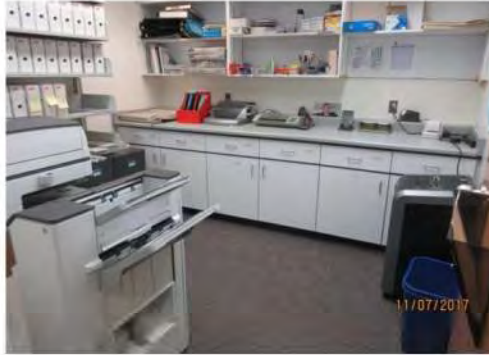
D2 2nd floor, Staff equipment / stationary room: No accessibility features identified. 2nd floor is not accessible.

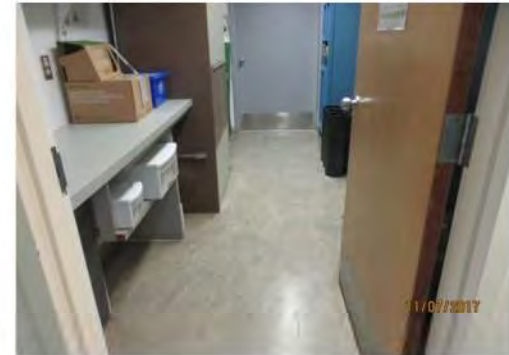
D3 1st floor, Equipment Room (off of central corridor): Clear door width is suitable for an existing condition. Knob door hardware is not accessible.

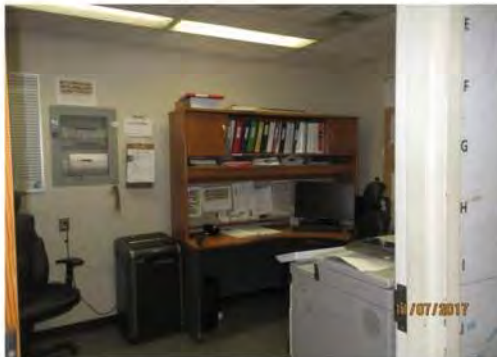
D4 1st floor, Duty Officer Office / Alarms Room: No accessibility features identified.

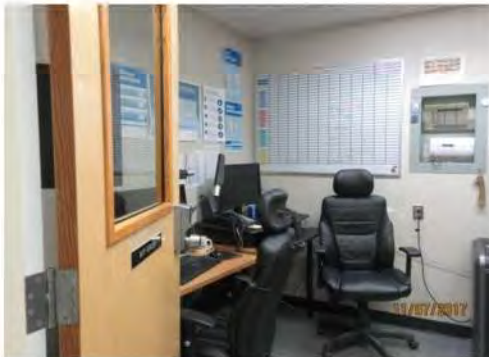
D5 1st floor, Duty Officer Office / Alarms Room: Clear door width is suitable for an existing condition. Knob door hardware is not accessible. Lower edge of vision panel is too high. No accessibility features identified.

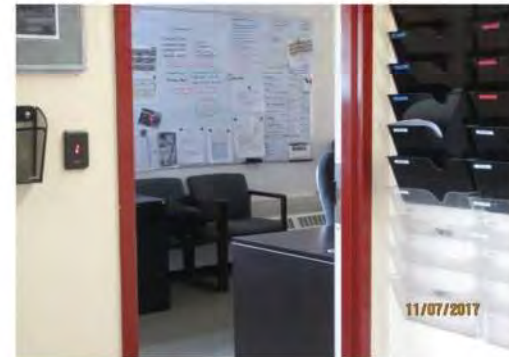
D6 1st floor, Dispatch / PSCC: Clear door width is suitable for an existing condition. Knob door hardware is not accessible. No accessibility features identified.

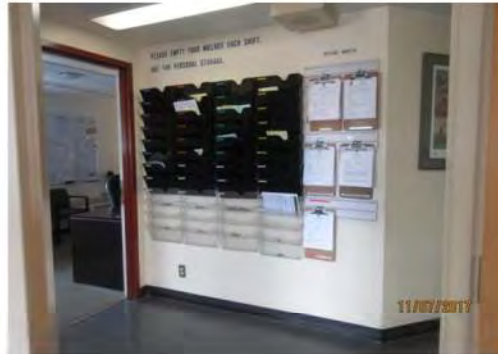
D7 1st floor, mailboxes (adj.), to main entrance: A range of mounting heights are available. Generally designed for standing height users.

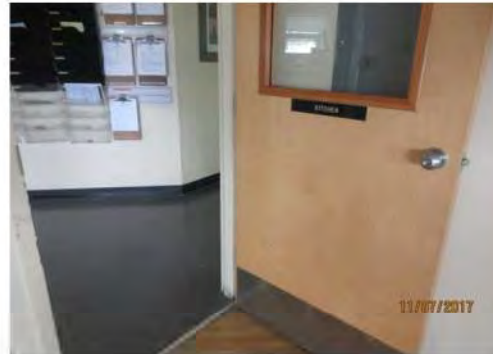
D8 1st floor, Kitchen entrance #1: Clear door width is suitable for an existing condition. Knob door hardware is not accessible. Lower edge of vision panel is too high.

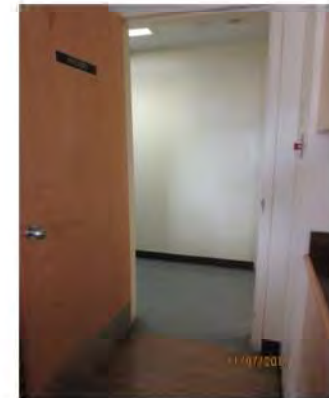
D9 1st floor, Kitchen entrance #2: Clear door width is suitable for an existing condition. Knob door hardware is not accessible.

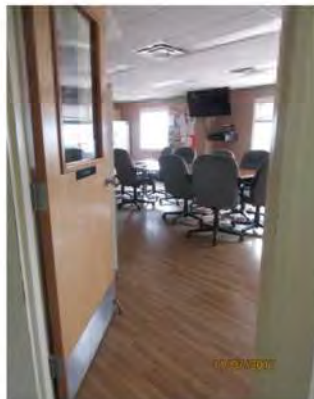
D10 1st floor, Kitchen, view from entrance #1: No accessibility features identified. However, interior floor space is open concept and potential accommodations can be made.

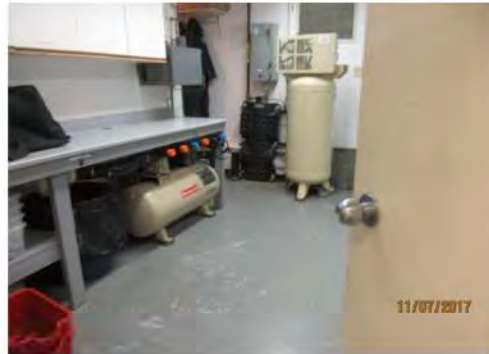
View of Sensitive Equipment Room, 1st floor.

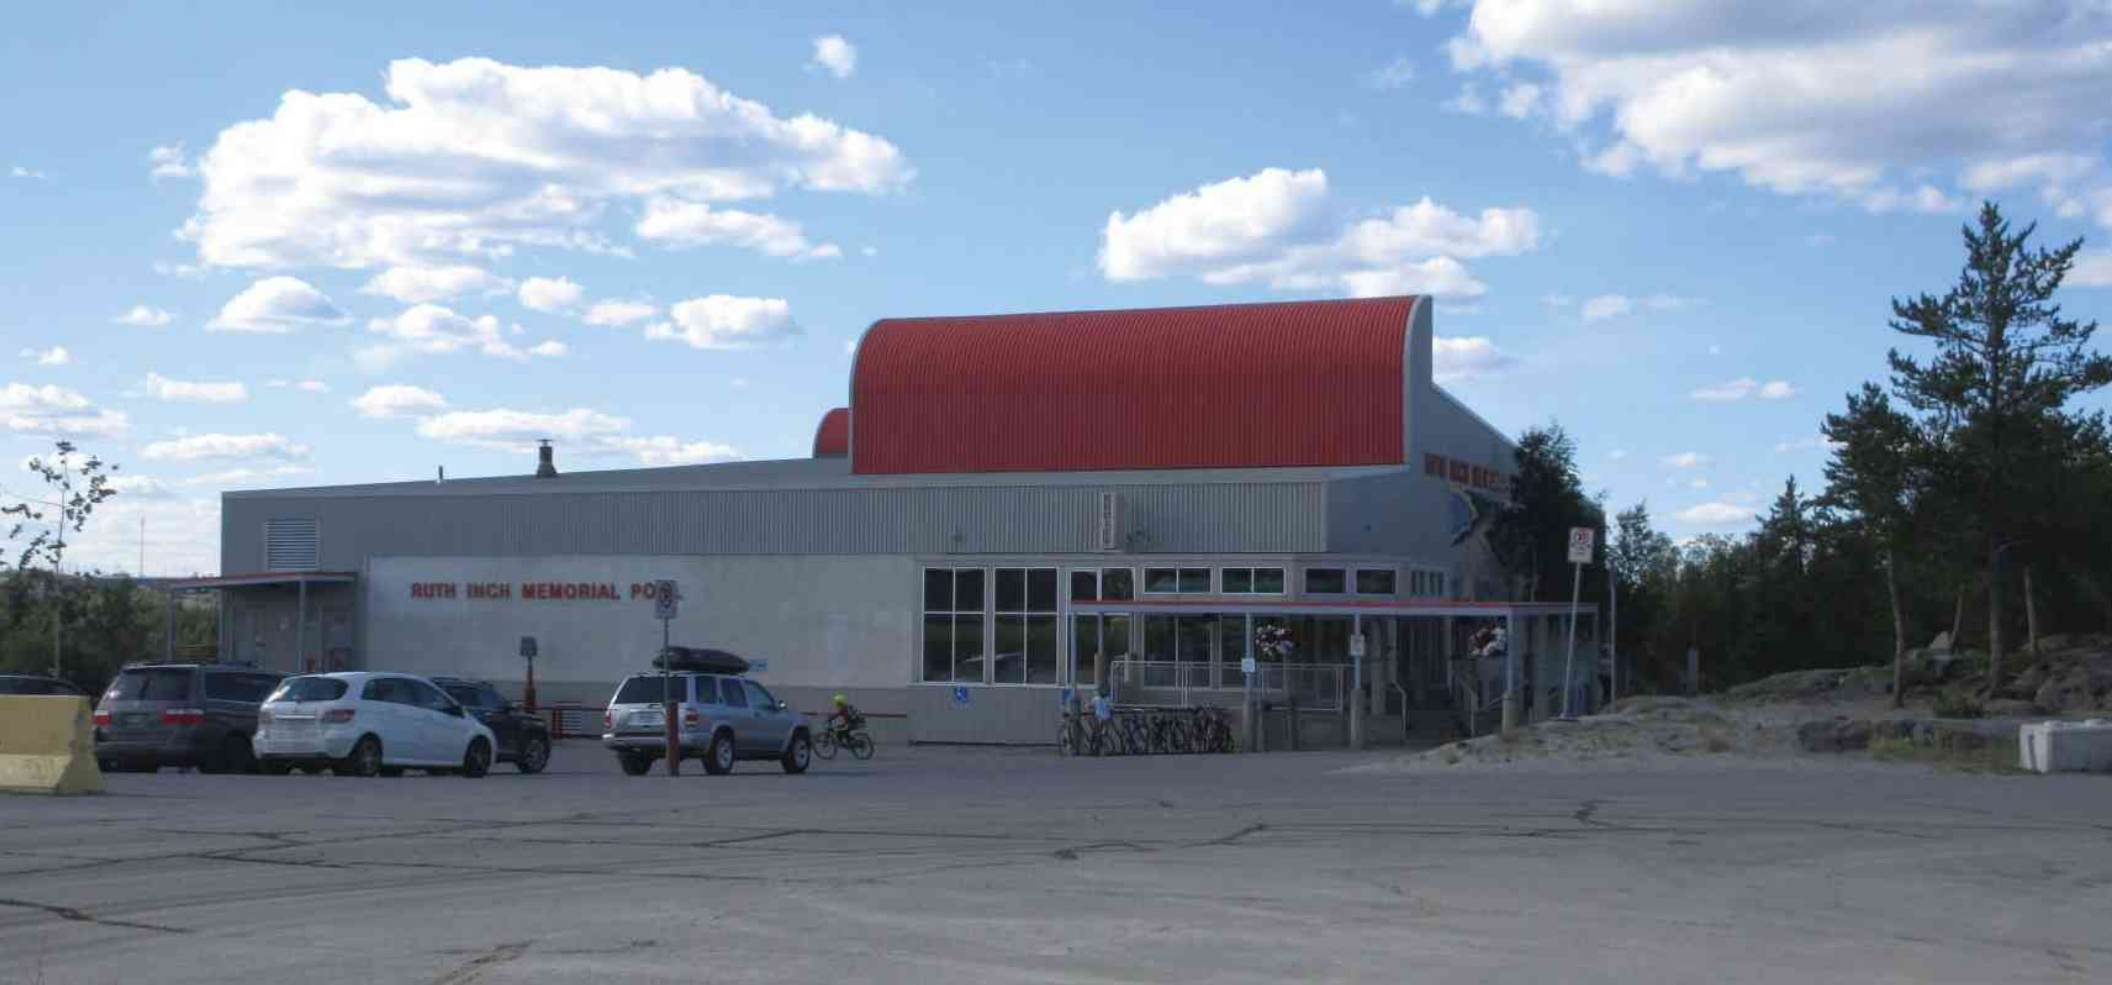
Barrier Removal Action Plan

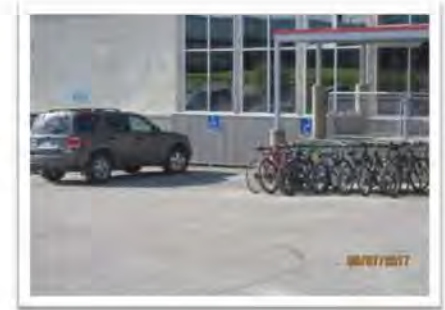
SECTION A: EXTERIOR ENVIRONMENTS

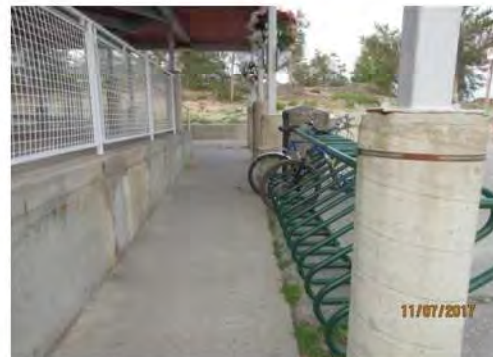
A11 No directional sign is provided to guide users to main accessible entrance. Placement of bicycle rack adjacent to accessible route results in potential bumping and tripping hazard.

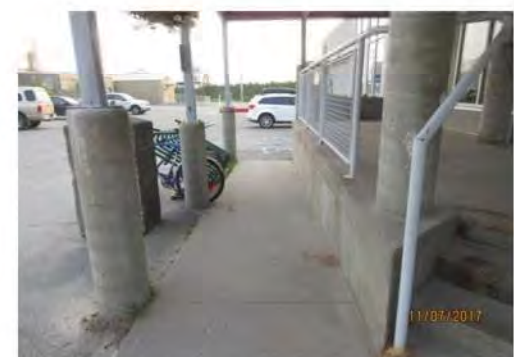
A12 View of approach to and from main entrance. Surface of accessible route is in good condition.

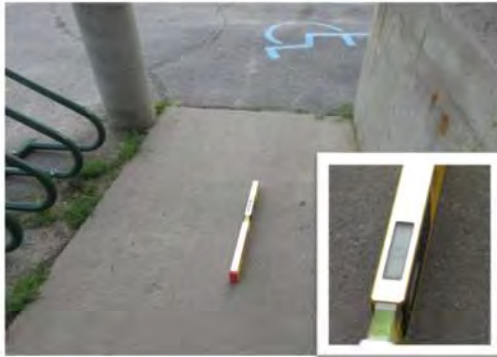
A13 Approach to main entrance from accessible parking spaces (lower section): Running slope is on-compliant at 5.9%.

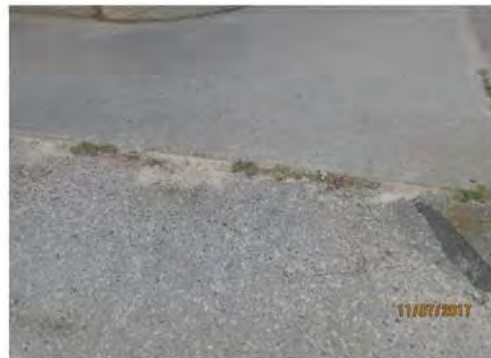
A17 Approach to Main Entrance: Some settlement & heaving between concrete & asphalt surfaces, resulting in potential tripping hazard.

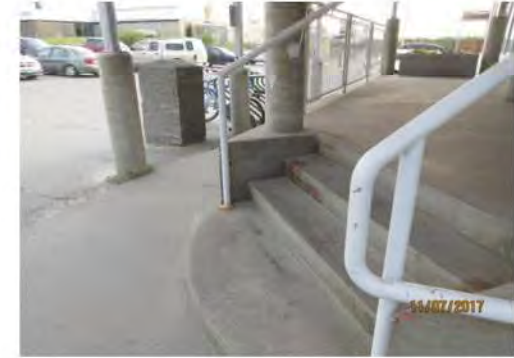
A18 Main Entrance: Stair handrail extensions are too short or not provided. No colour contrast is provided on stair nosings.

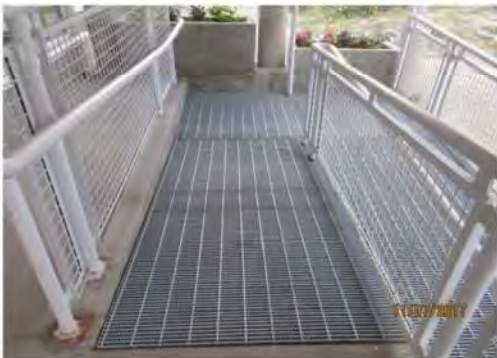
A22 View of ramp, from top landing and main entrance area. Extensions at top landing are not provided but would also be potential bumping hazards.

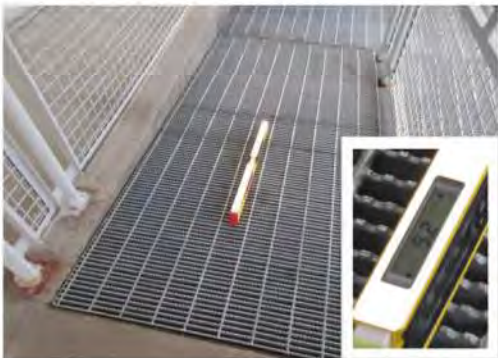
A23 Ramp, top section (adj. to entrance): Running slope is too steep and non-compliant at 9.2%.

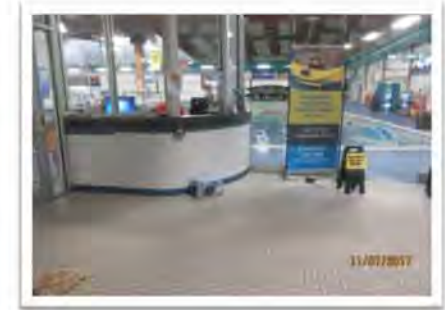
SECTION B: INTERIOR ENVIRONMENTS

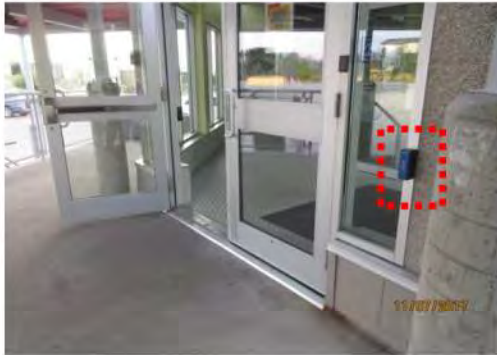
B1 Main entrance: Level access is provided off of landing serving stair/ramp. PDO control is small (typical) and mounted on window mullion where door swings towards control and user.

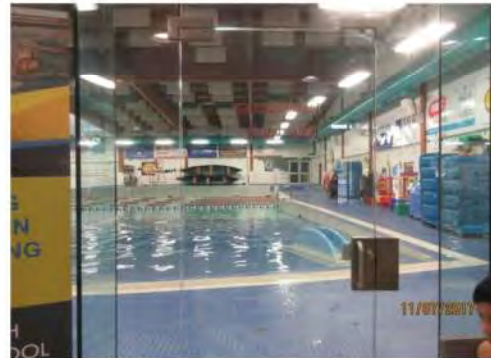
B11 Viewing Area: Glazing is not marked to prevent potential bumping hazards especially for users with vision loss. Glass entry/exit door and adjacent glazing is difficult to identify, especially for users with vision loss.

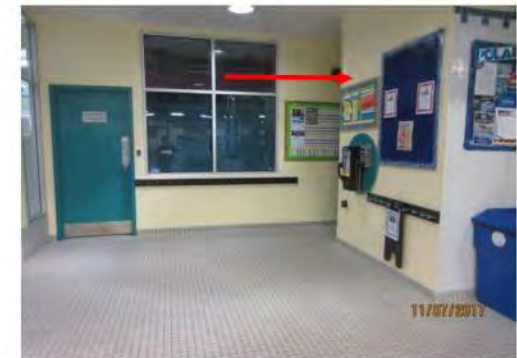
B12 Viewing Area: Generally, information on display boards is posted too high.

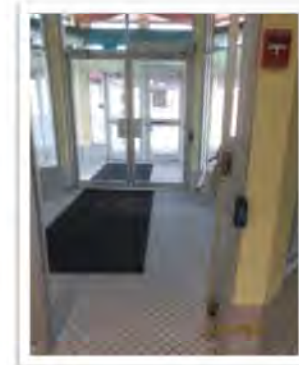
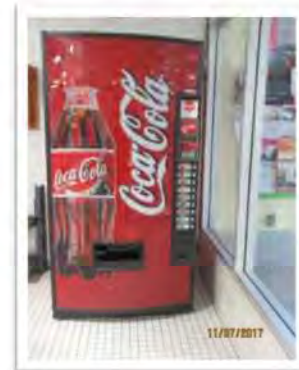
SECTION C: BUILDING SYSTEMS, CONTROLS & COMMUNICATIONS

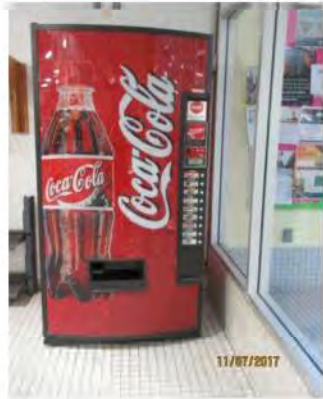
C1 All operating controls are not accessible for existing vending machine (e.g., some upper controls exceed 1200 mm max).

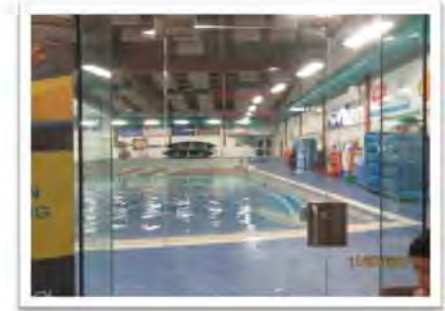
The following summary observations were made at the time of the audit:

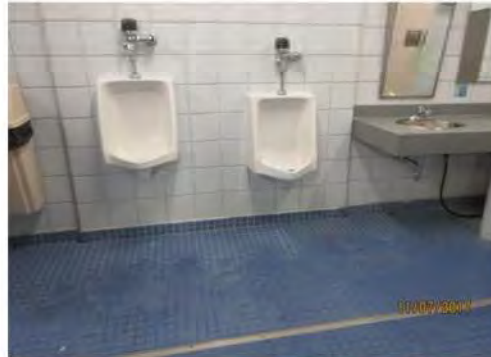
D17 Men's Change Room: A lowered urinal with auto flush control is provided. No upgrade is recommended for this feature since facility is scheduled for replacement.

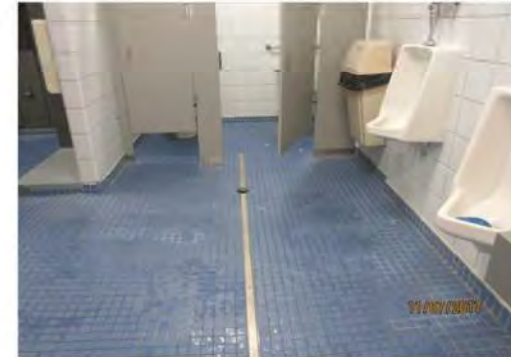
D18 Men's Change Room: View of clear floor space adjacent to urinals and approach to accessible stall. Cross-slope of some areas of floor surface is non-compliant and designed for drainage.

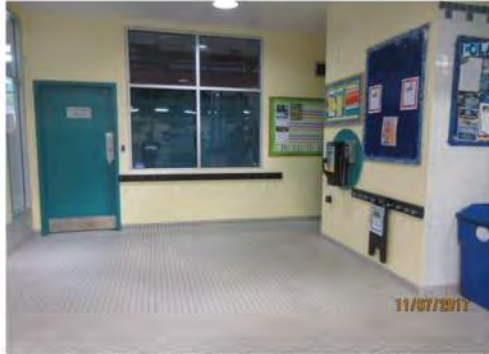
View of typical pool deck surface. Beige colour contrast is provided around pool perimeter, compared to darker blue tile surfacing.

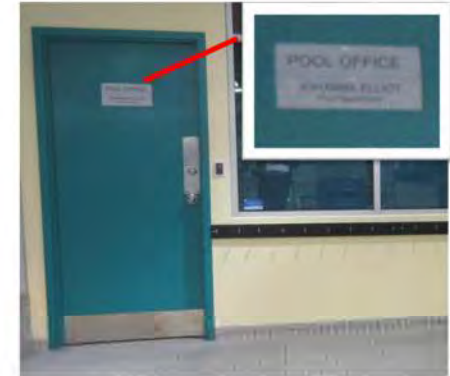
Pool Office: Entrance was locked at time of audit. Clear width is generally suitable for existing condition. Knob door hardware is not accessible.

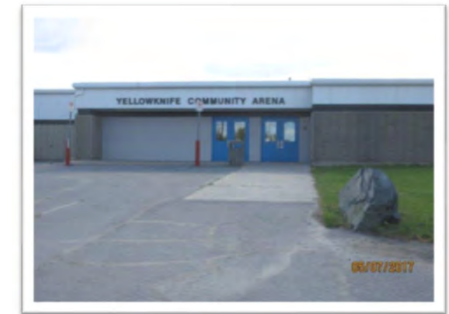
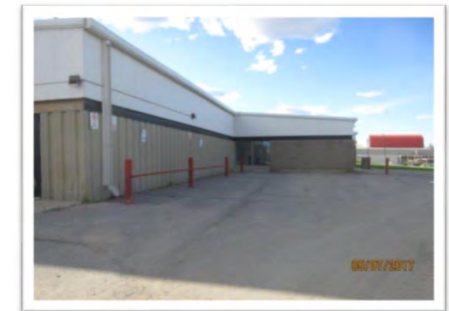
SECTION A: EXTERIOR ENVIRONMENTS

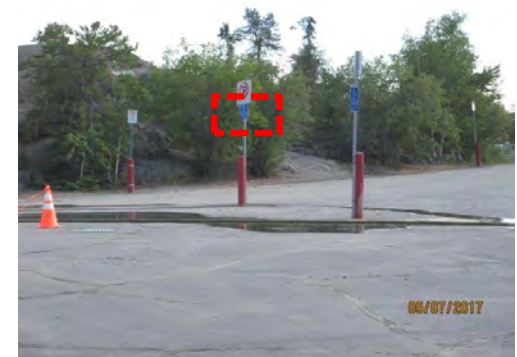
A3 Approach to main entrance, from west side. Accessible parking spaces are marked with post-mounted signage only, which is damaged / obstructed. No separated or marked accessible route is provided (e.g., directional signage), leading to main entrance.

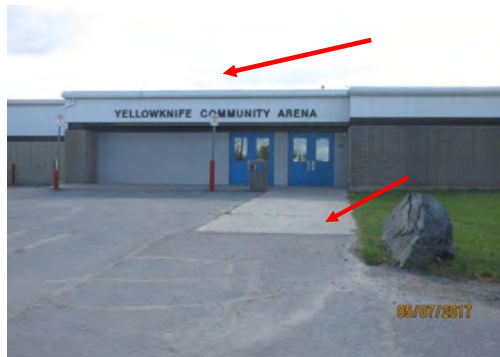
A4 View of facility identification signage. Generally, no directional signage is provided throughout site to guide users to main entrance. Transition from separated accessible pedestrian route and drive aisle (asphalt surface) is not marked with TWSI.

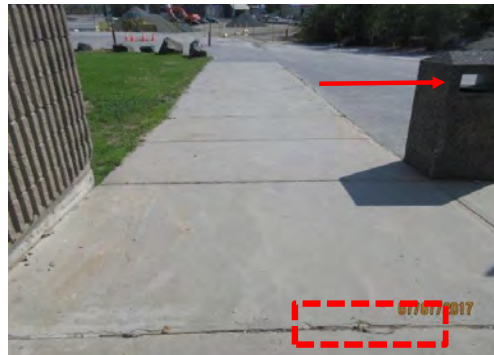
A8 Approach to main entrance (west side). Some heaving / settlement between concrete sections observed. No seating/rest areas identified, with limited to no amenities / street furniture. One accessible waste receptacle identified adjacent to main entrance.

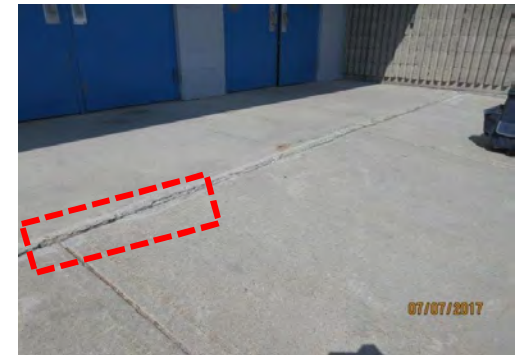
A9 Approach to main entrance (west side). Some heaving / settlement between concrete sections observed.

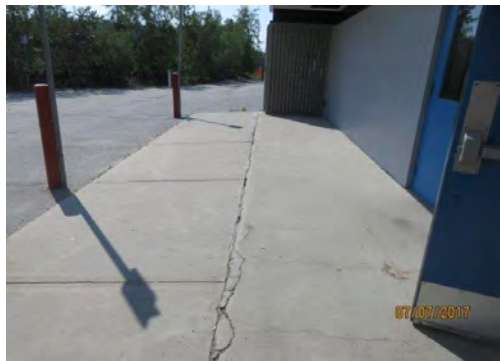
A10 Approach to main entrance (looking towards south side of site). Some heaving / settlement between concrete sections observed. Excessive cross-slope in some areas, exceeding 2%.

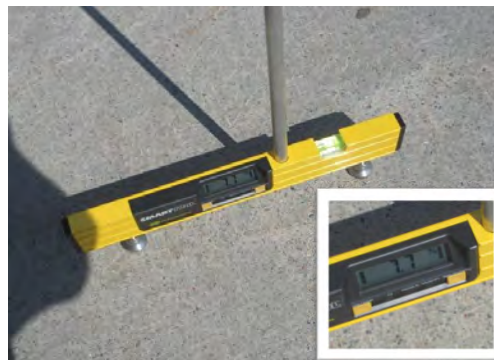
A11 Concrete surface, adjacent to main entrance: Excessive running-slope at 7.8% (adjacent to wall on north side of walkway).

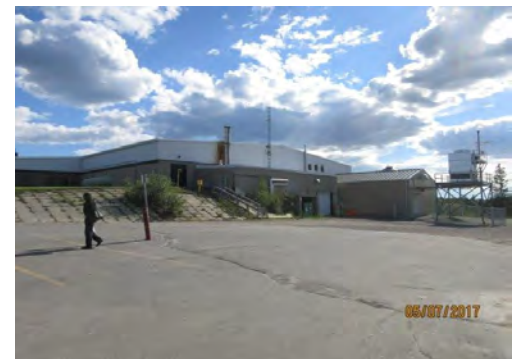
A15 View of stair system, from exit door (north side).
General view of exterior conditions adjacent to exit as well as entrances to storage facilities.

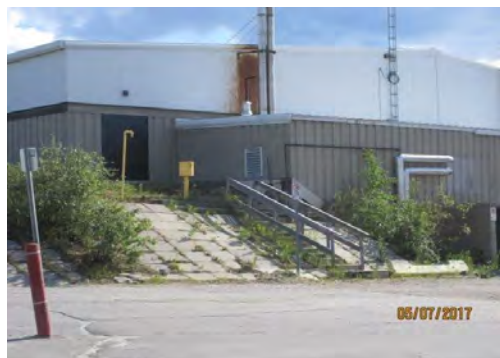
A16 View of stair system, from exit door (north side).
Wooden stair generally does not meet current requirements including oversized wooden handrails. Level access is not provided at exit door (multiple level changes when exiting).

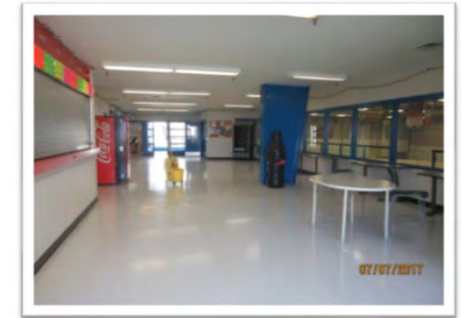
SECTION B: INTERIOR ENVIRONMENTS

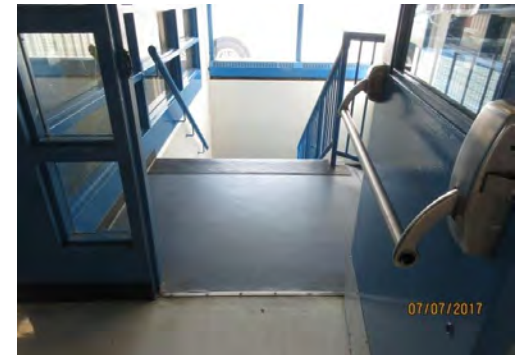
B15 Entrance to Central Stair: Thumb-latch door hardware is not accessible. Lower edge of glazing is too high but there is additional glazing as part of sidelights that enhances visibility to prevent any potential bumping hazards.

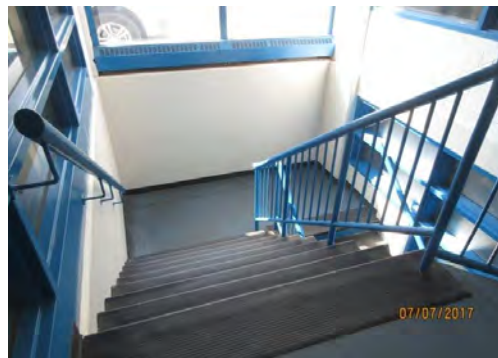
B16 Central Stair: No colour contrasted nosings provided. Handrail grasping dimension is too large. No handrail extensions are provided at top landing.

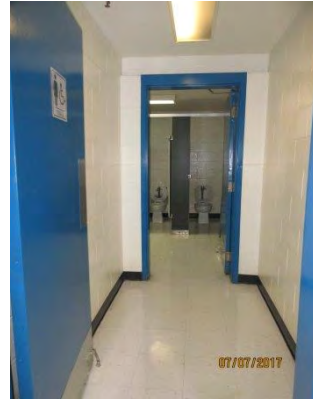
B20 Women's Accessible Washroom (Upper Level): Entrance doors have limited clear width but suitable for an existing condition. Door mounted signage is not accessible. No power door operators are provided.

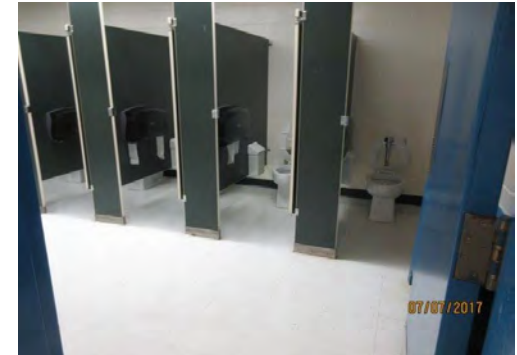
B21 Women's Accessible Washroom (Upper Level): View of interior floor space for circulation adjacent to entrance and regular stalls.

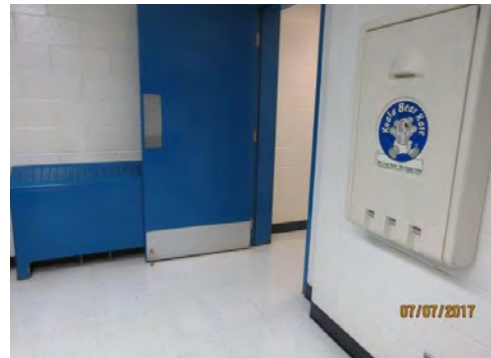
B23 Women's Accessible Washroom (Upper Level): Entrance doors have limited clear width but typically suitable for an existing condition.

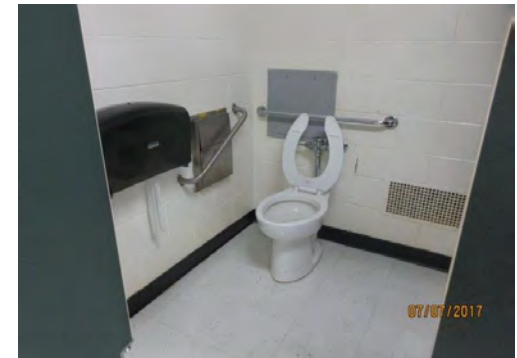
B24 Women's Accessible Washroom (Upper Level): Stall floor space is limited. Flush control is not on transfer side of toilet. Stall doors are not self closing. No L-shaped grab bar is provided at side of toilet. Toilet paper dispenser mounted too far and too high.

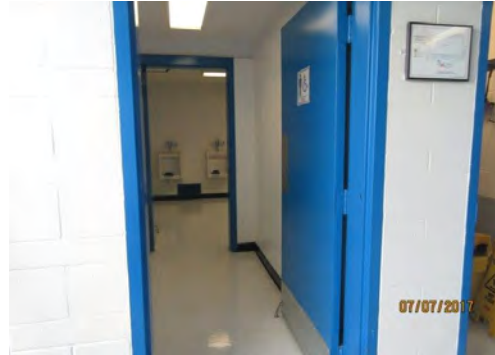
B26 Men's Accessible Washroom (Upper Level): Entrance doors have limited clear width but typically suitable for an existing condition. Door mounted signage is not accessible. No power door operators are provided.

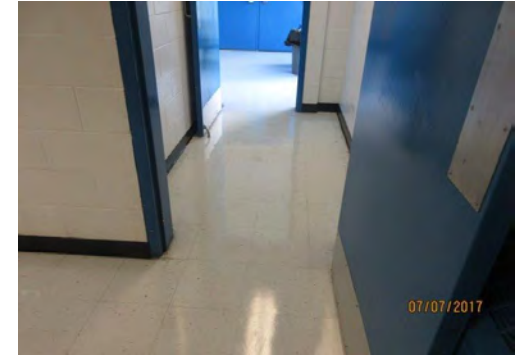
B27 Men's Accessible Washroom (Upper Level): Entrance doors have limited clear width but typically suitable for an existing condition.

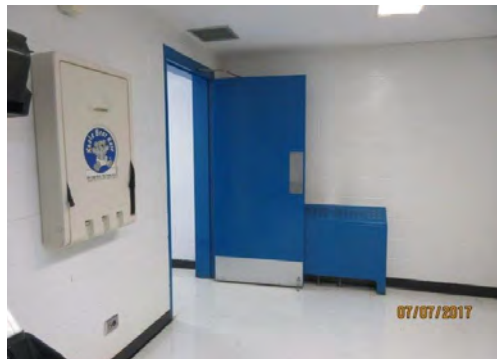
B28 Men's Accessible Washroom (Upper Level): Entrance doors have limited clear width but typically suitable for an existing condition. No power door operator is provided.

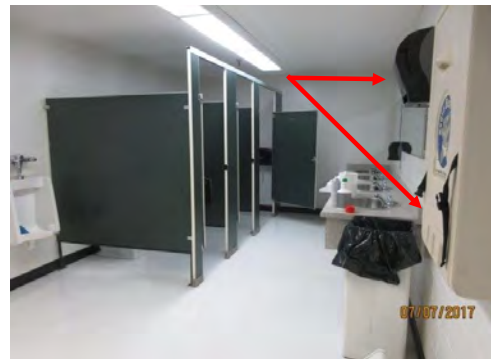
B29 Men's Accessible Washroom (Upper Level): View of interior floor space for circulation. No accessible lavatory is provided with knee space clearance below. Amenities are typically mounted too high (hand dryer & baby change tables).

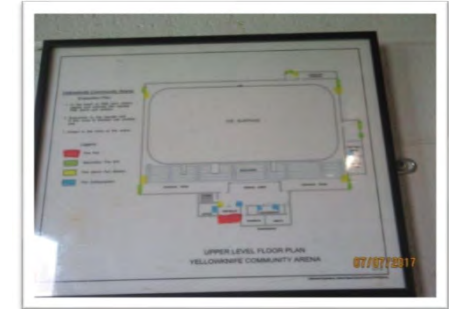
SECTION C: BUILDING SYSTEMS, CONTROLS & COMMUNICATIONS

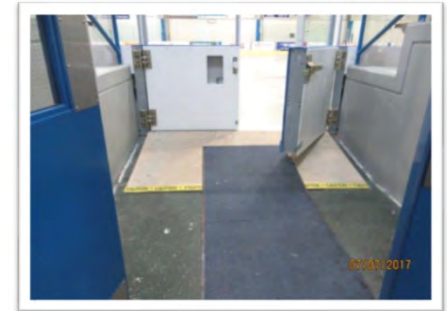
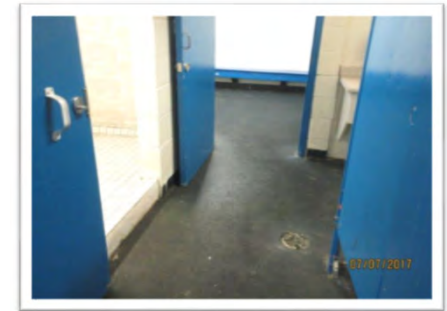
SECTION D: SPECIAL FACILITIES, SPACES & ENVIRONMENTS

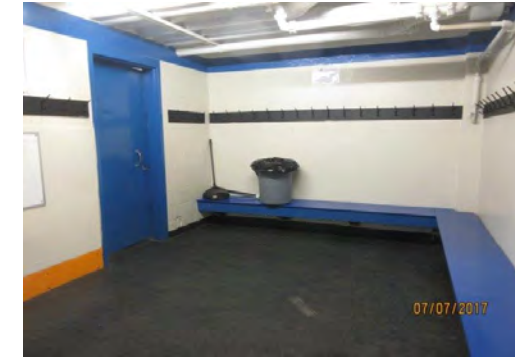
D54 Change Room #1 (Lower Level, south side): Typical change room conditions.

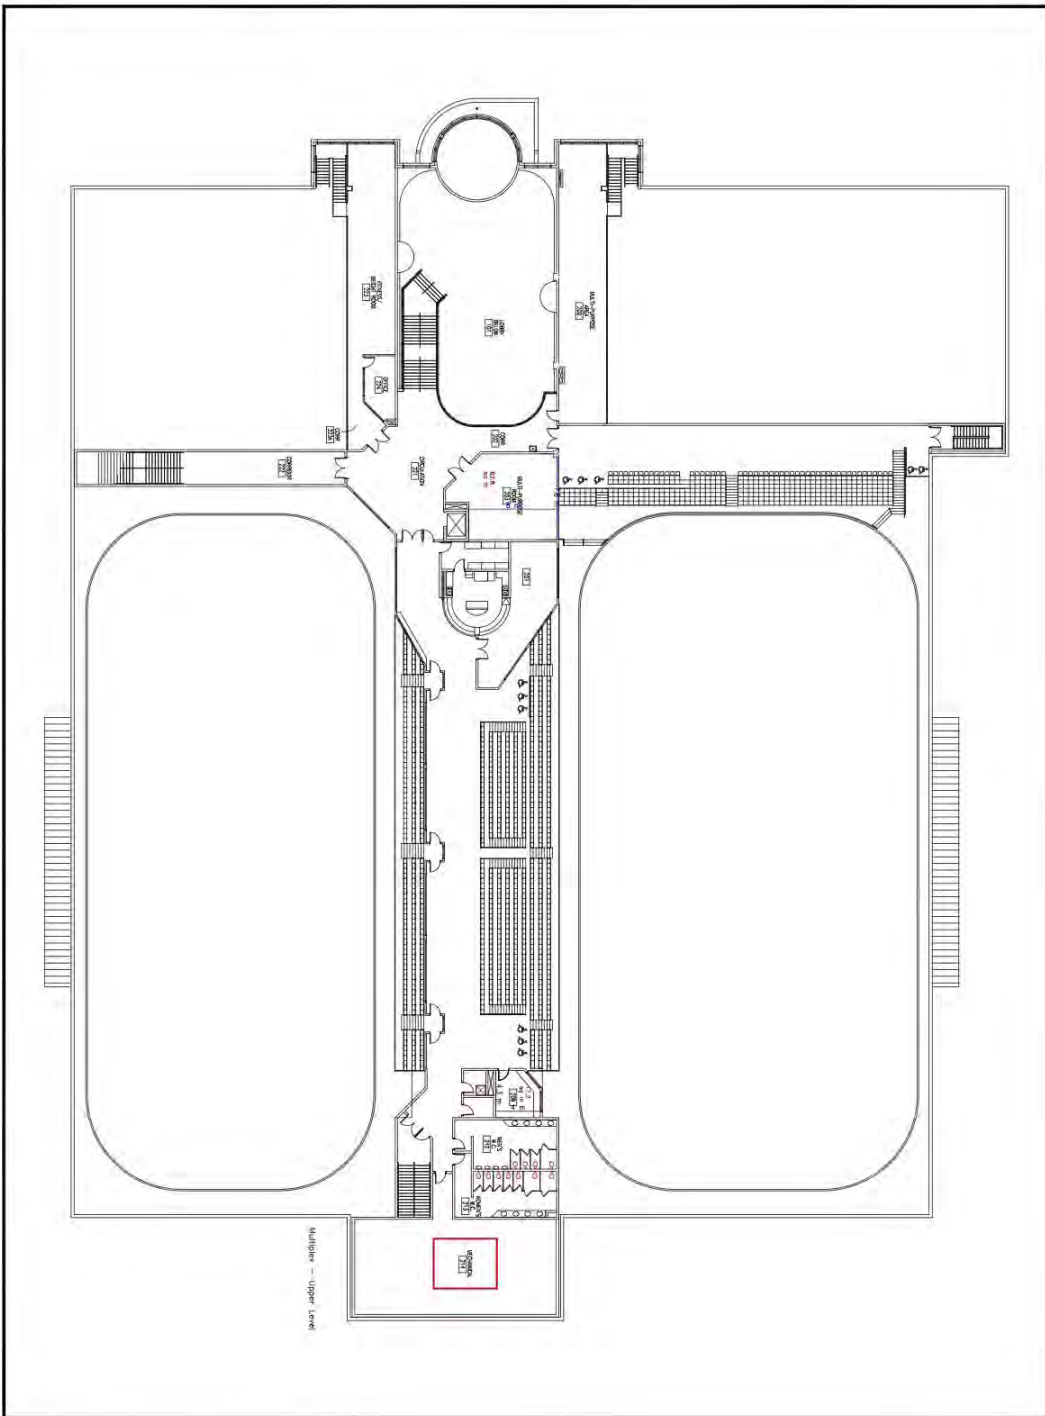
4 Barrier Removal Actions

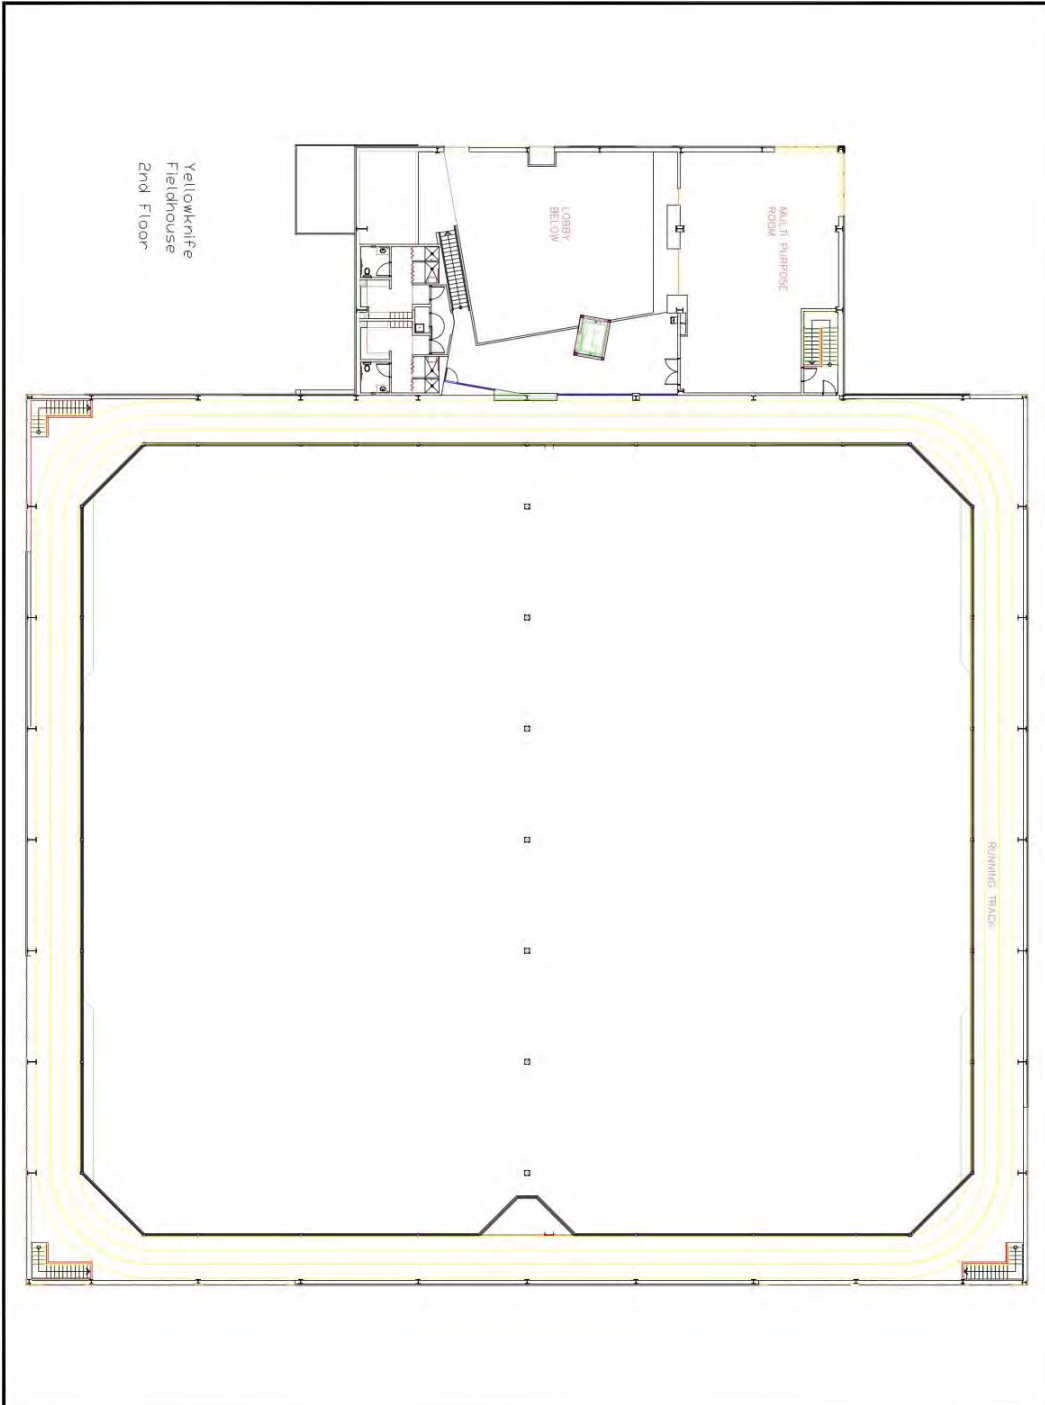
4 Barrier Removal Actions

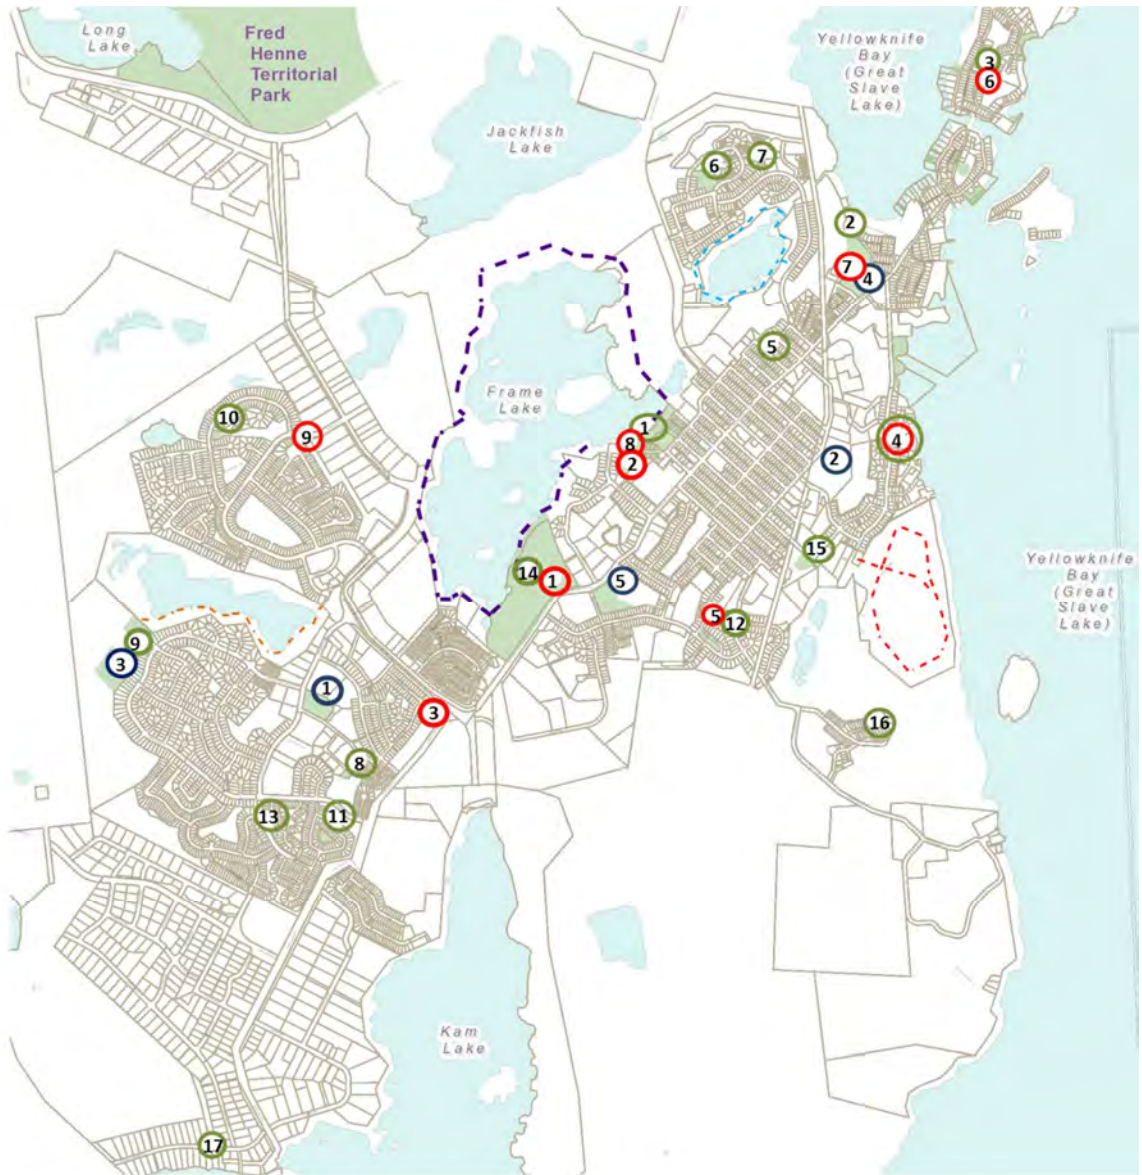
1.2 Audit Methodology

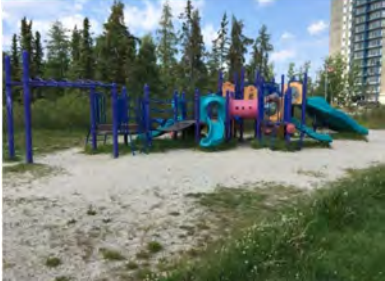
<p>Play Structures</p>	<p>Elevated play structure components are installed at most playgrounds with no ramps or transfer devices. Few play structures incorporate ground level components, colour contrasted components or sensory components.</p> <p><i>Photo: Parker Field Playground</i></p>

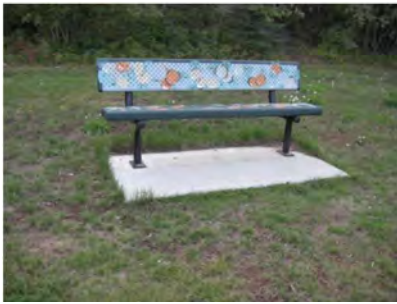
2.3 Barrier Removal Actions

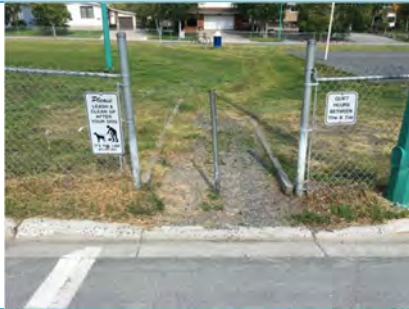
Lighting	<p>Lighting is sometimes provided at sports courts. This audit considered summer activities that take place in summer months during daylight hours. Lighting may be useful where courts are converted to skating rinks for winter use.</p> <p><i>Photo: Streetlights at Forrest Drive Basketball court</i></p>

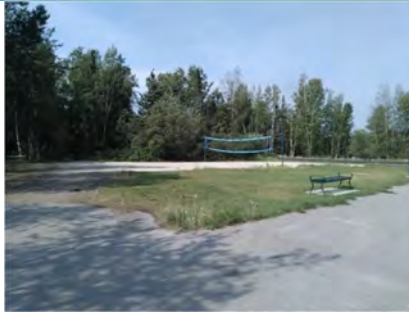
3.3 Barrier Removal Actions

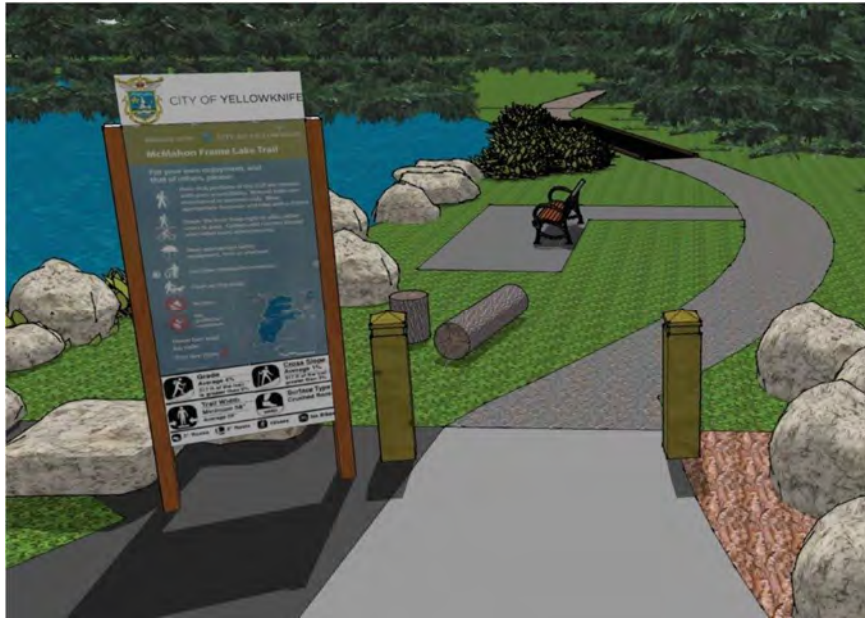
Key features that will help to make elements more inclusive are summarized below:

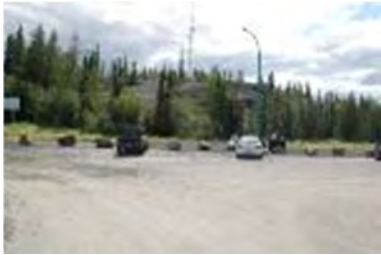
Routes	<p>Long segments of the Frame Lake and Niven Lake trails are well surfaced and drained, providing relatively accessible segments to those with limited mobility or vision. Segments of other trails have potential to provide higher level of accessibility without damaging the natural environment.</p> <p><i>Photo: segment of Tin Can Hill trail that follows old roadway</i></p>

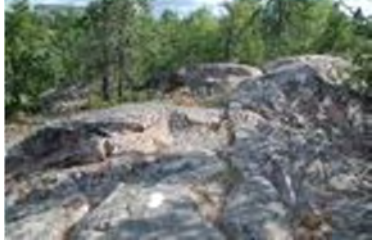
Trailheads	<p>The distance between trailheads along most of the trails audited provide users with options for completing longer or shorter segments of trails. Some trailheads are difficult to identify from parking or public sidewalks.</p>

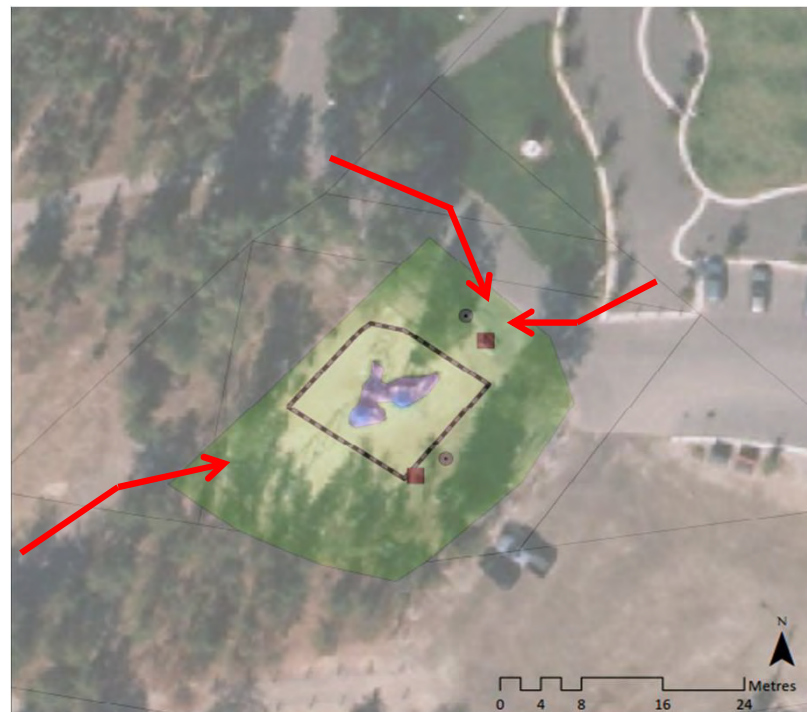
red lines/arrows indicate main routes and access points

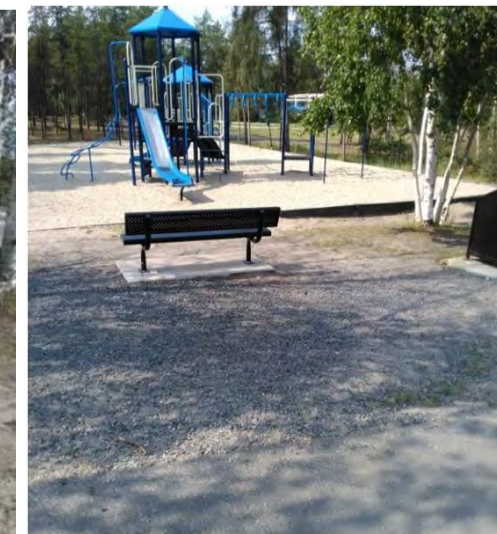
Site: 2. Josephine Walcer Playground
 Audit Date: 10-Jul-17
 Auditor: Beth Cowan

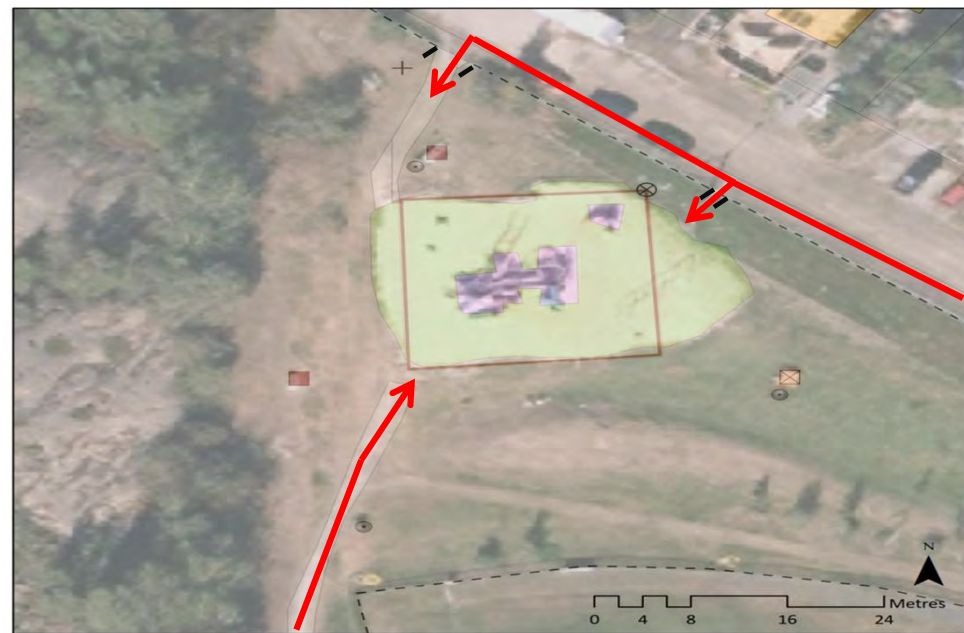
red lines/arrows indicate main routes and access points
