Barrier Removal Action Plan City Hall Grounds

**FOR STAFF REVIEW
D1 - December 2017**

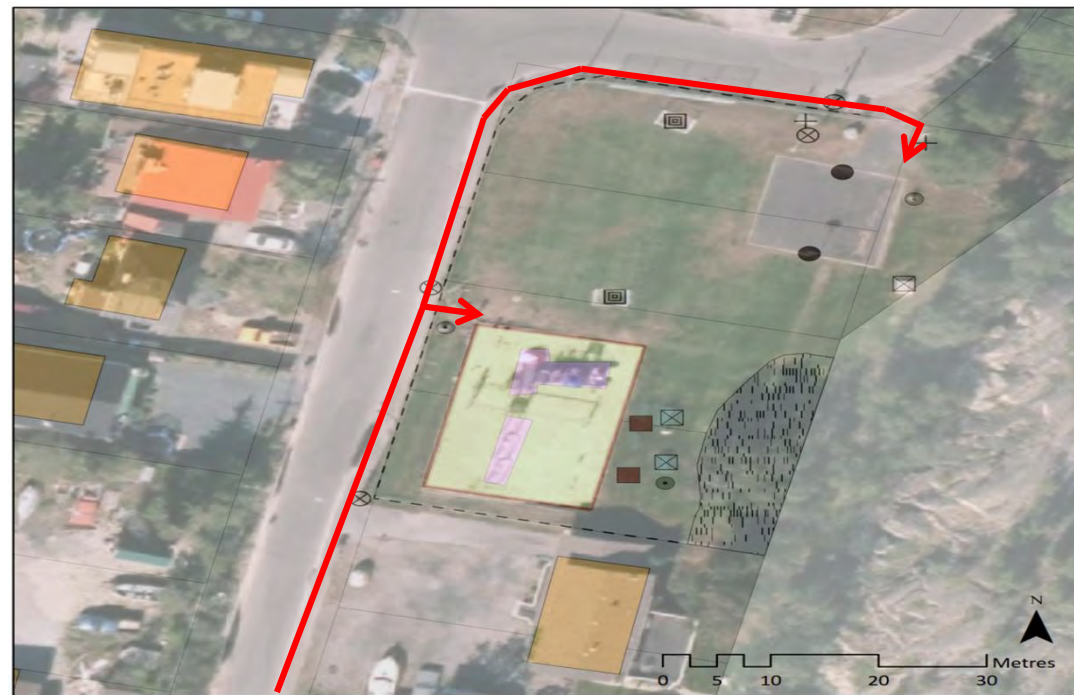
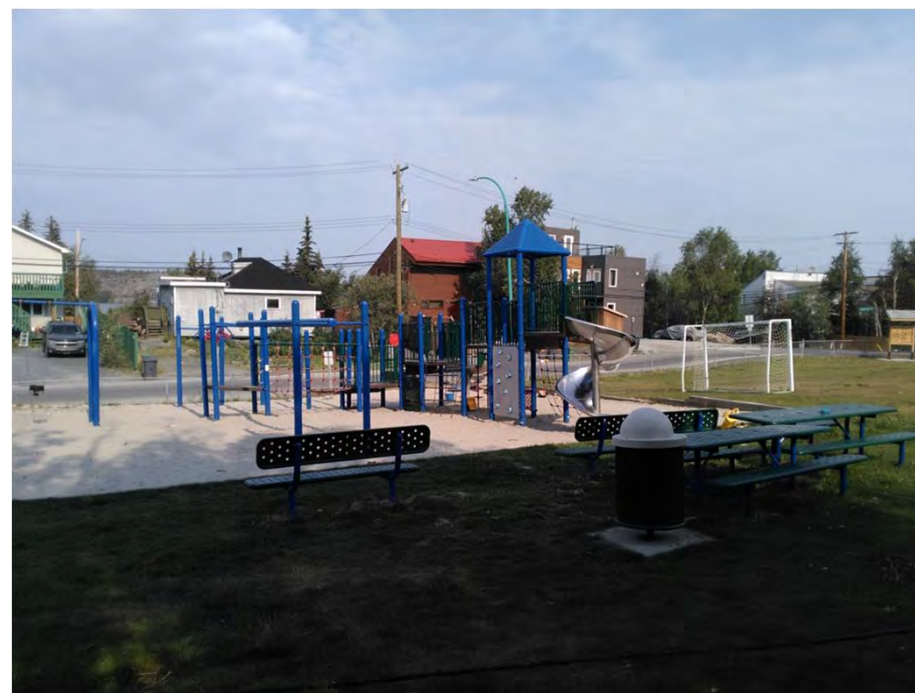
red lines/arrows indicate main routes and access points

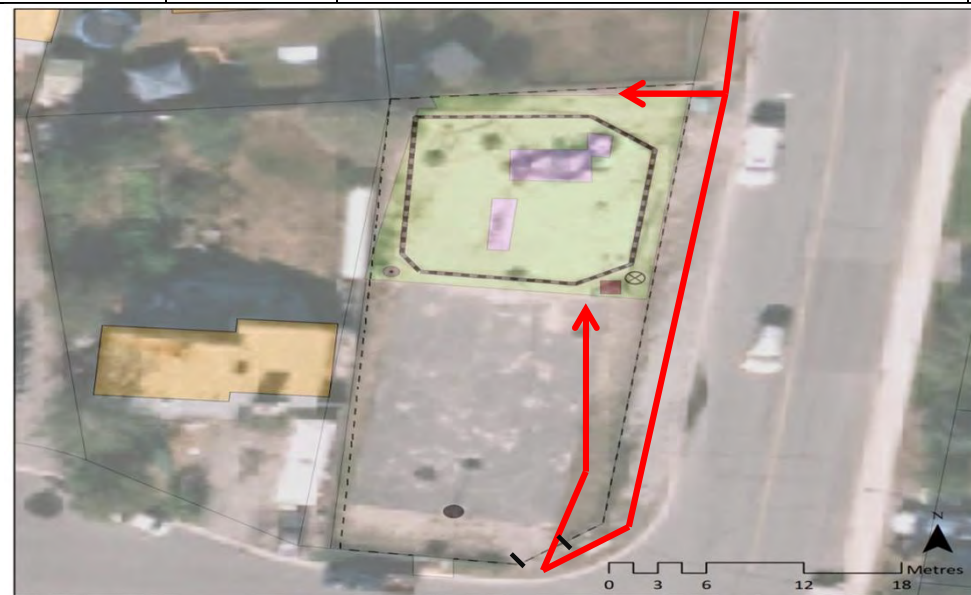
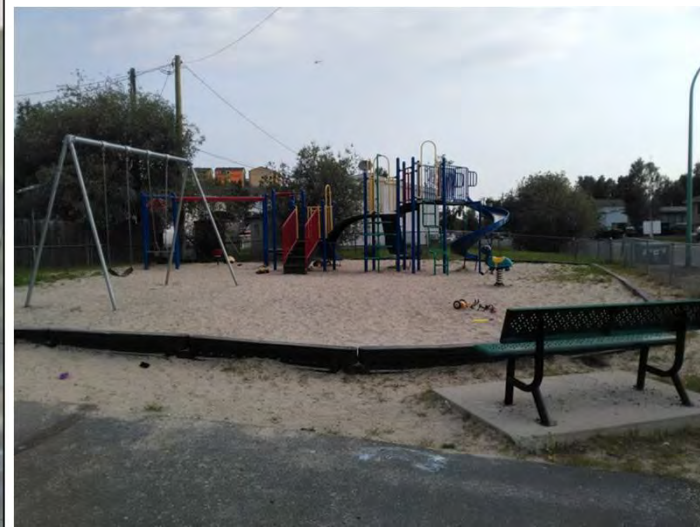
View to play area from SE entrance

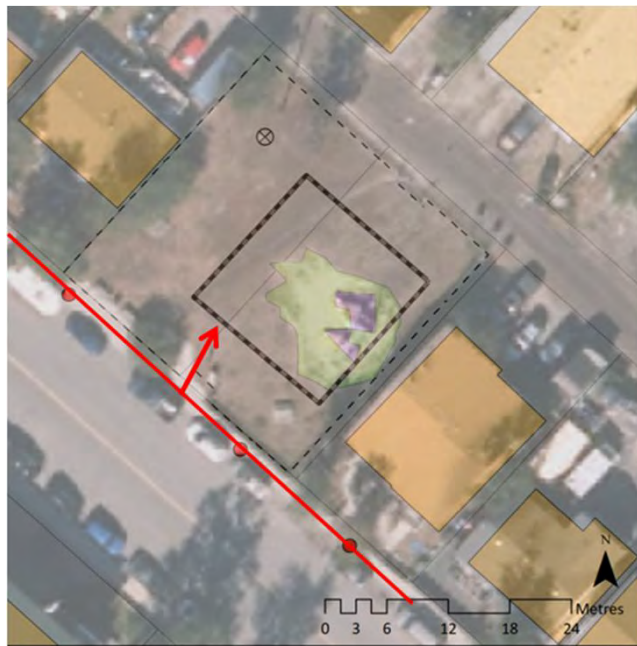
red lines/arrows indicate main routes and access points

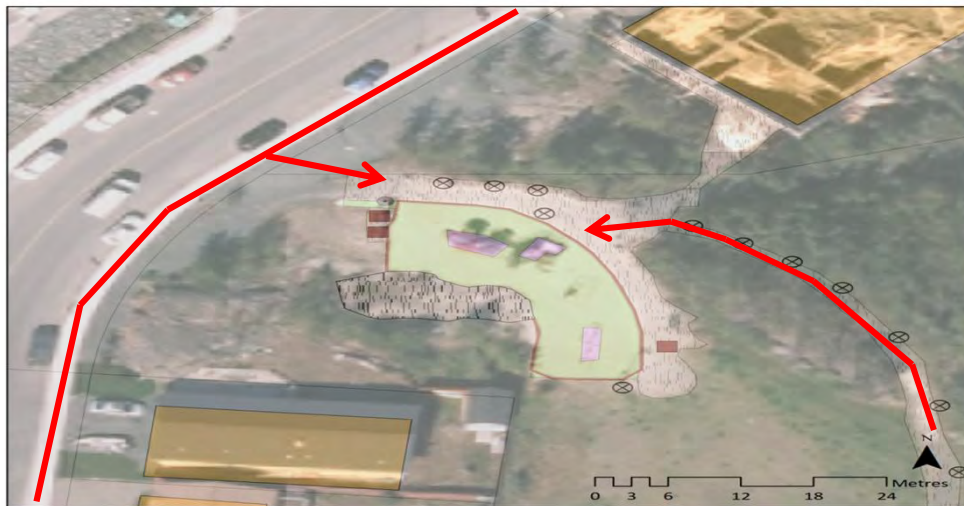
red lines/arrows indicate main routes and access points

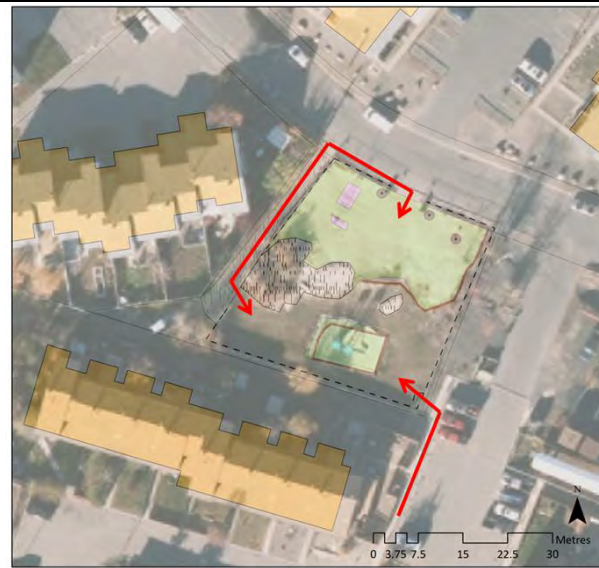
red lines/arrows indicate main routes and access points

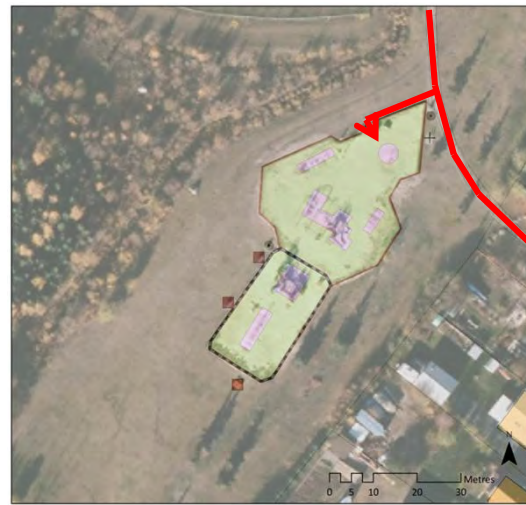
red lines/arrows indicate main routes and access points

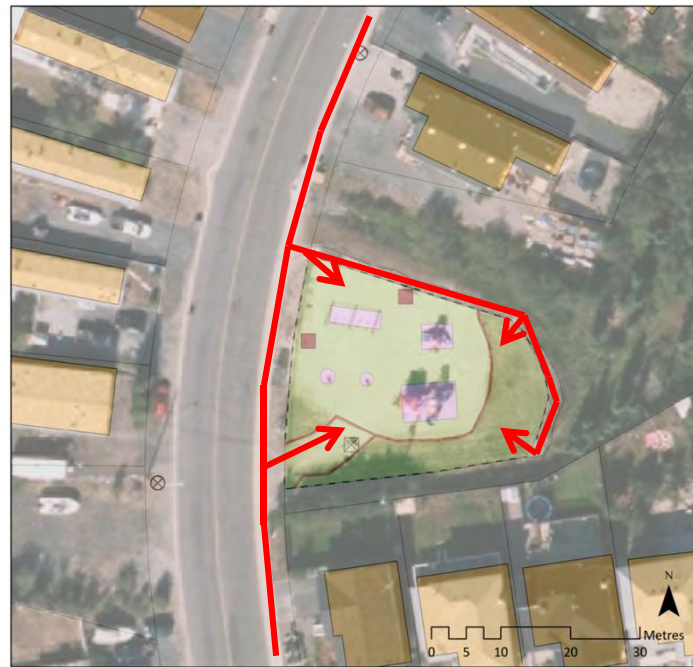
red lines/arrows indicate main routes and access points

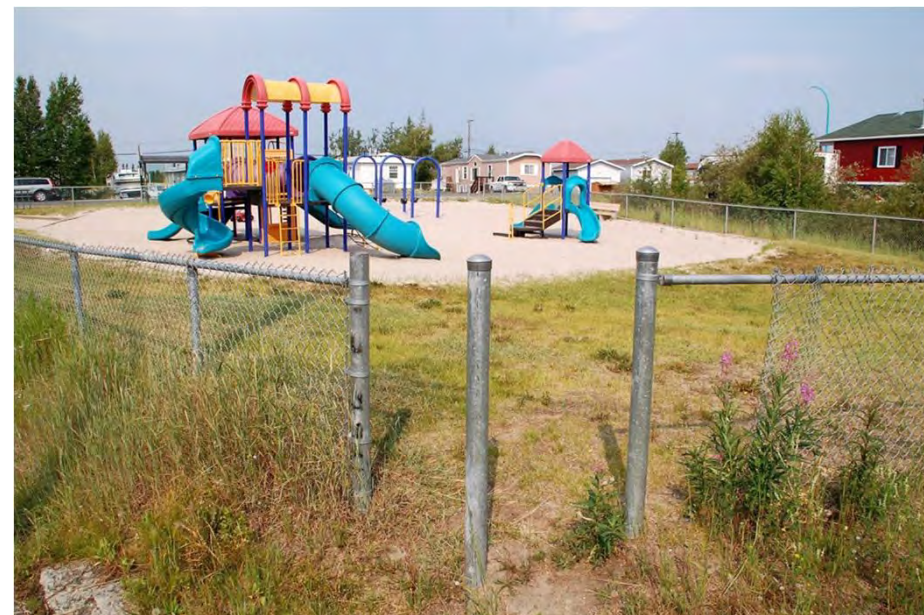
gate opening is less than recommended width and path is overgrown

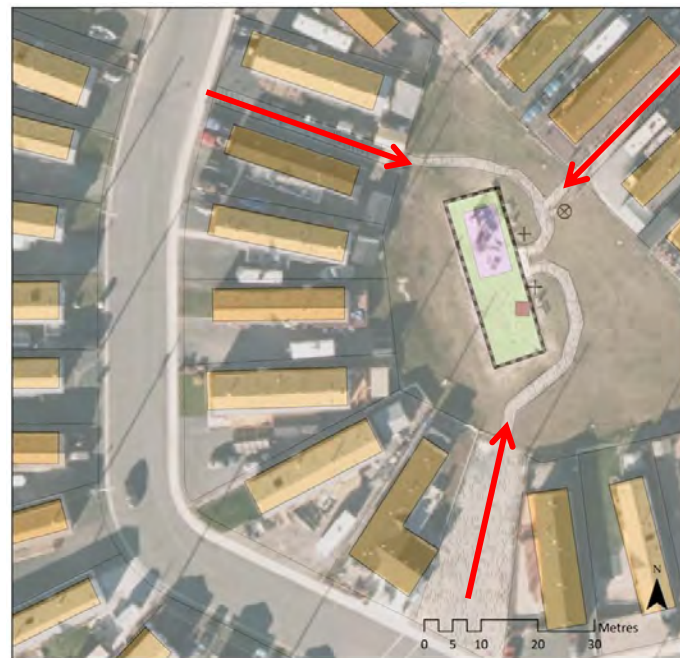
red lines/arrows indicate main routes and access points

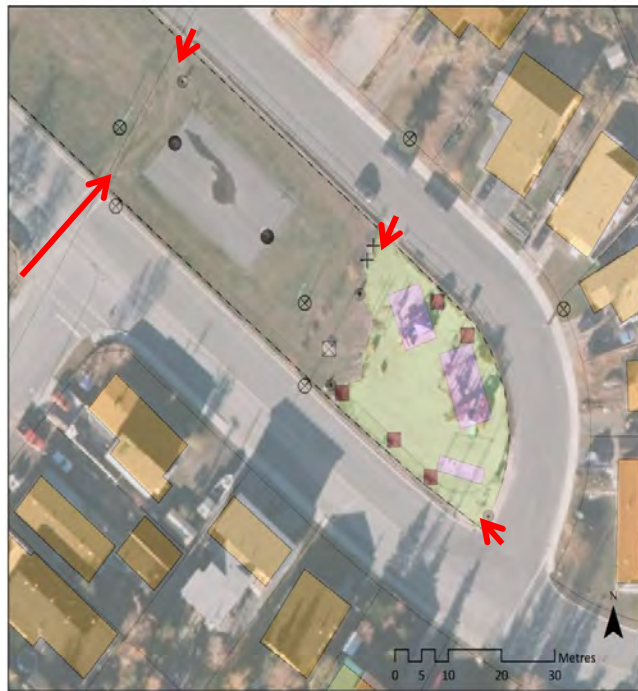
red lines/arrows indicate main routes and access points

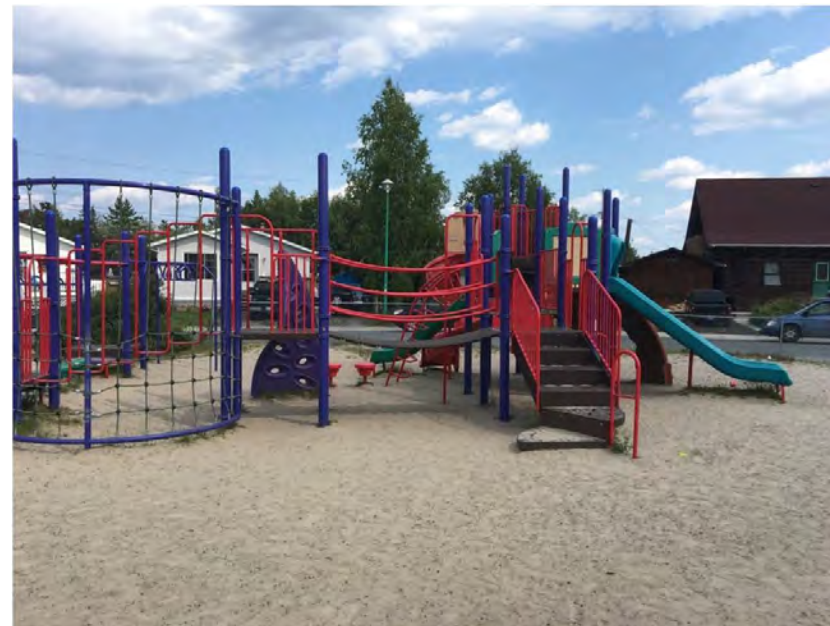
sand is not a recommended ground surface for accessibility

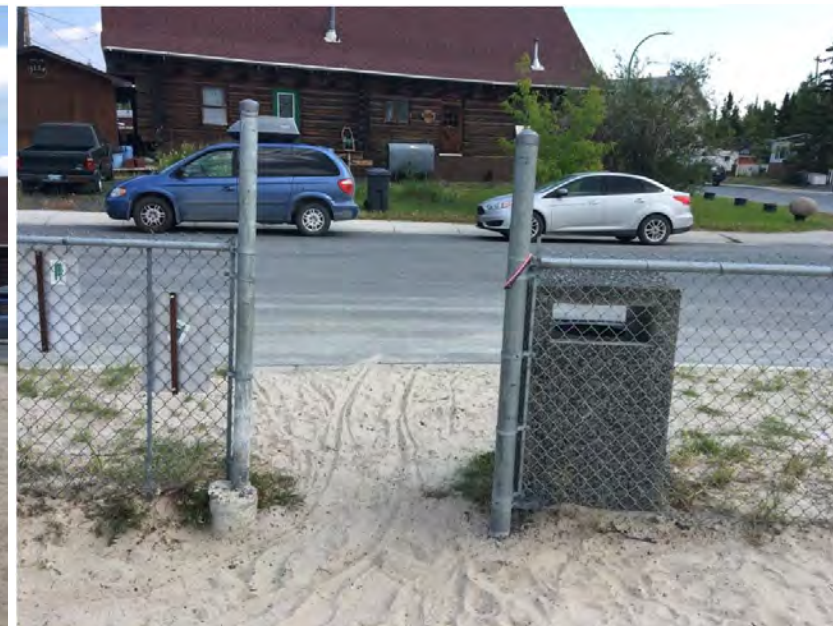
sandy routes create barriers to accessibility

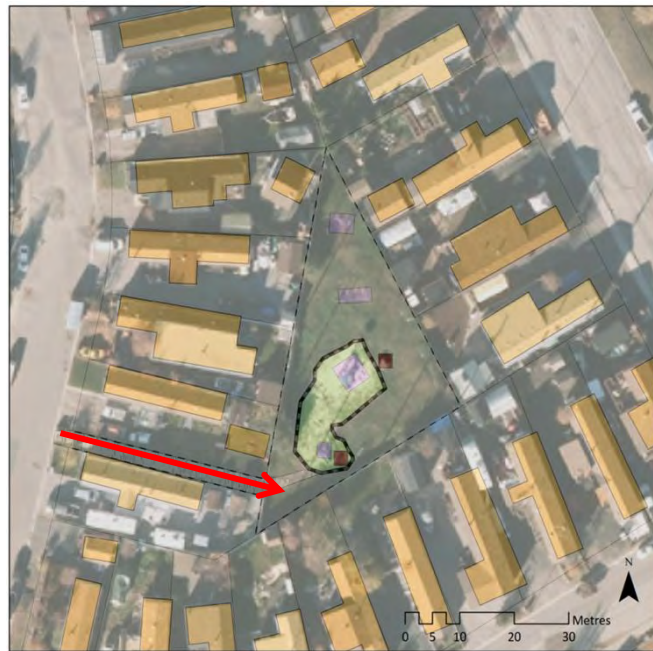
red lines/arrows indicate main routes and access points

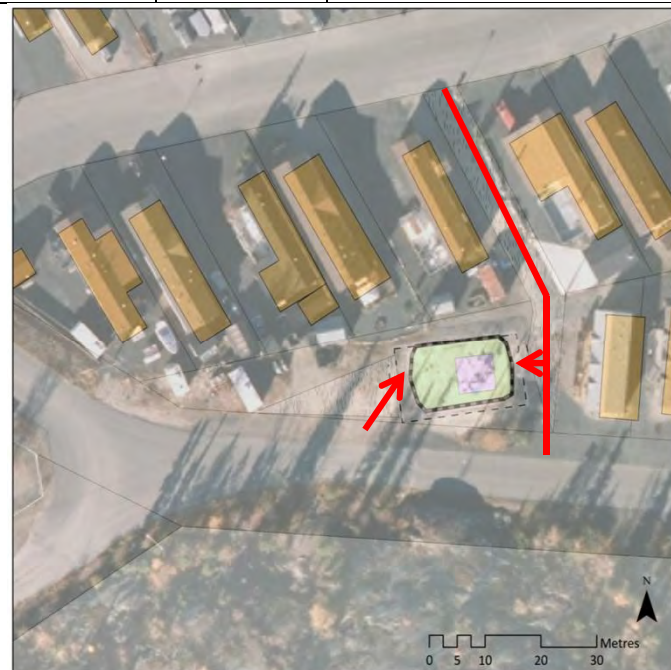
red lines/arrows indicate main routes and access points

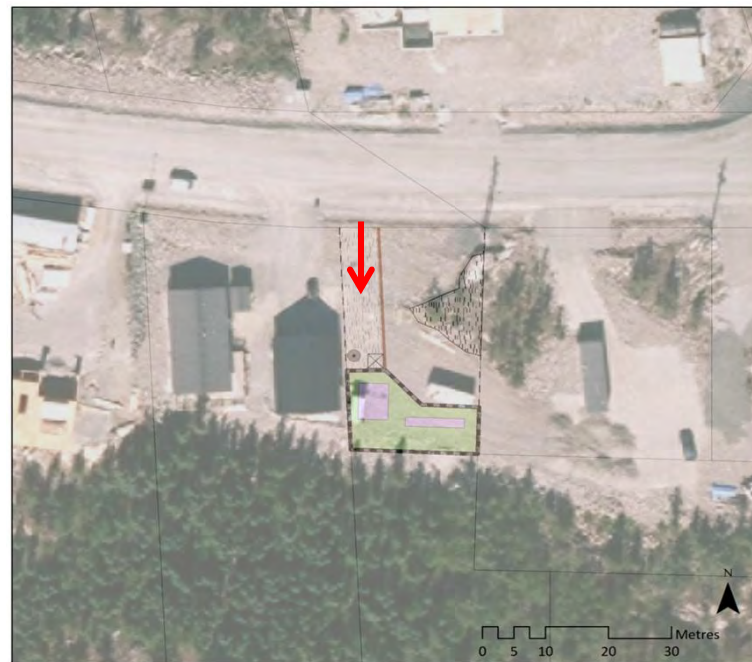
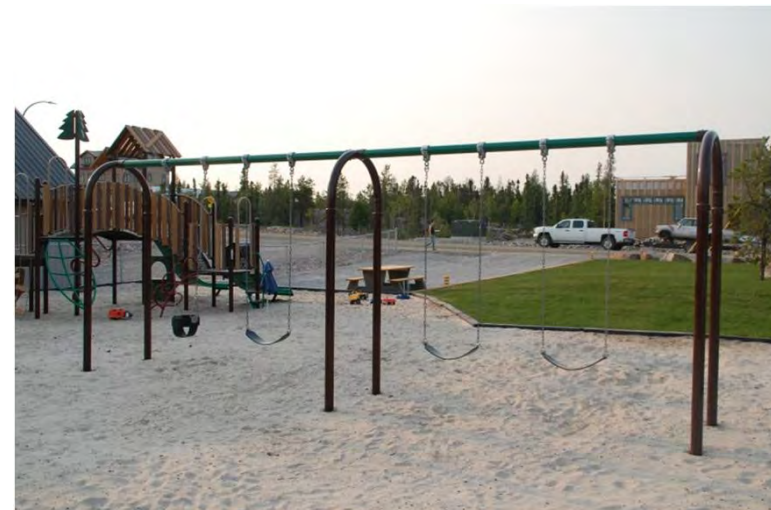
play structures are not accessible

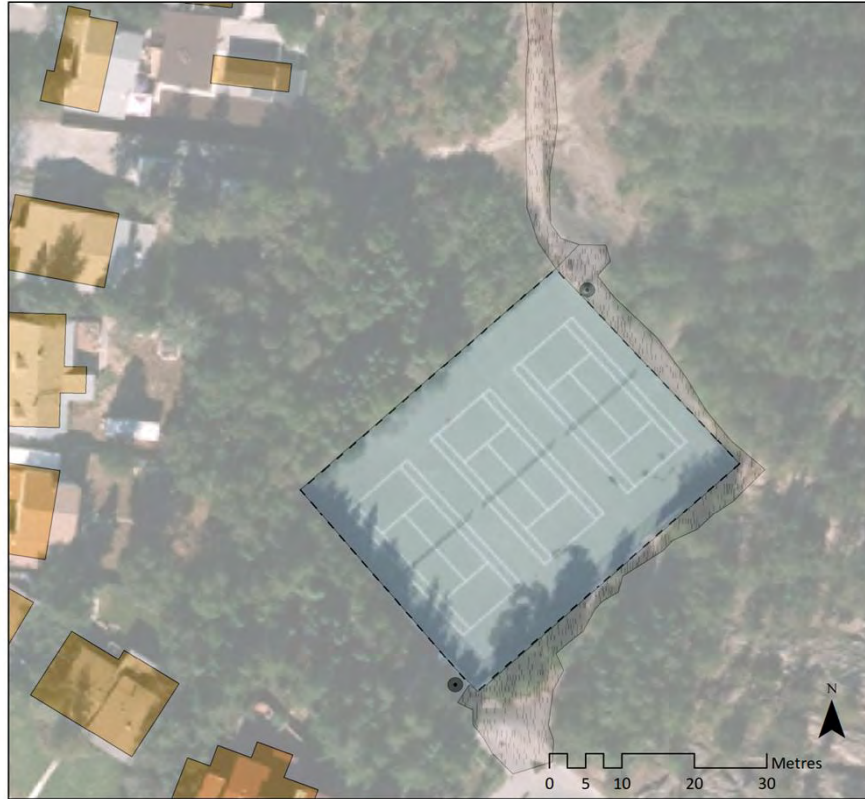
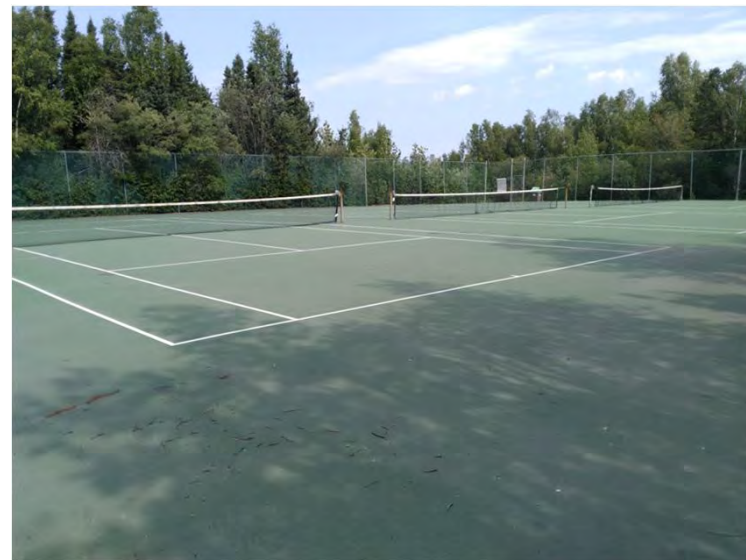
there are no benches in the court area

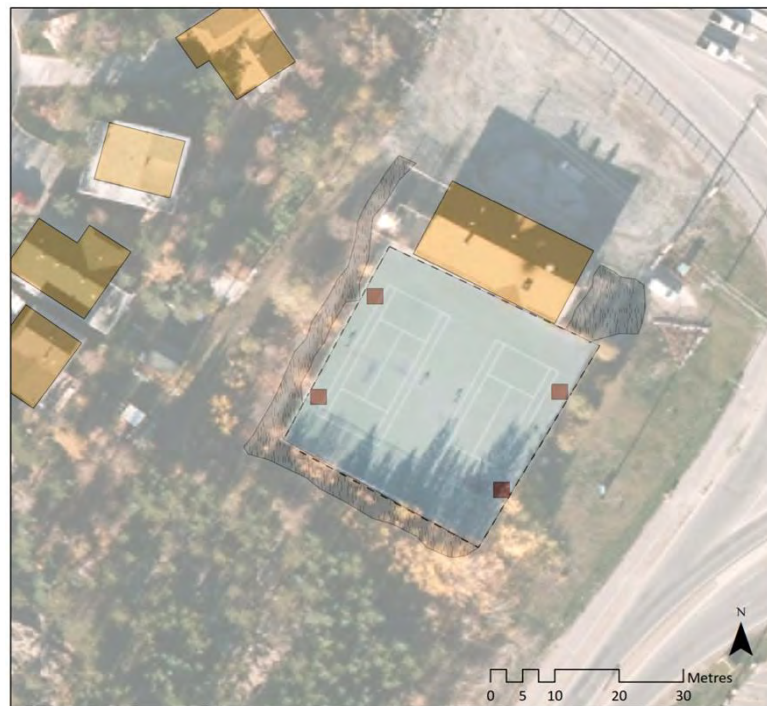
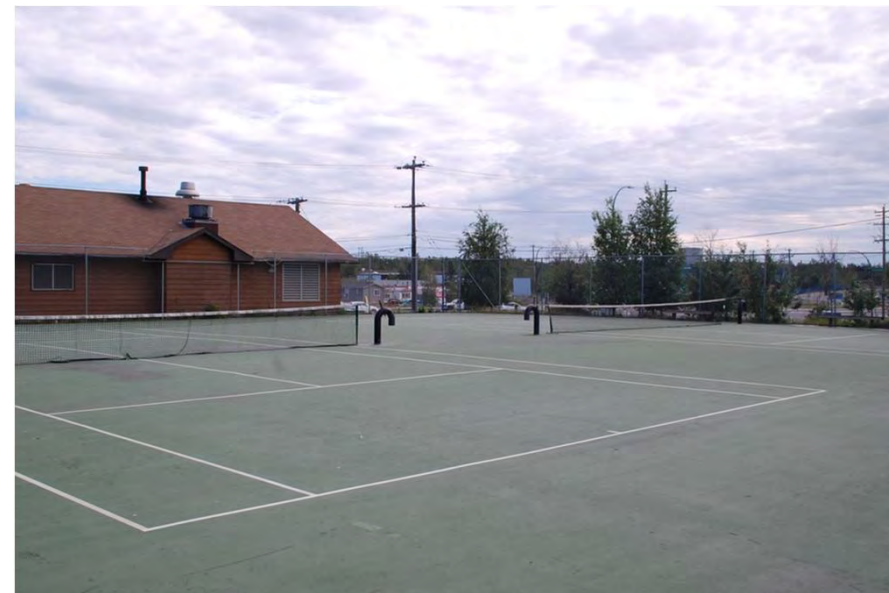
Site Budget Total \$5,900

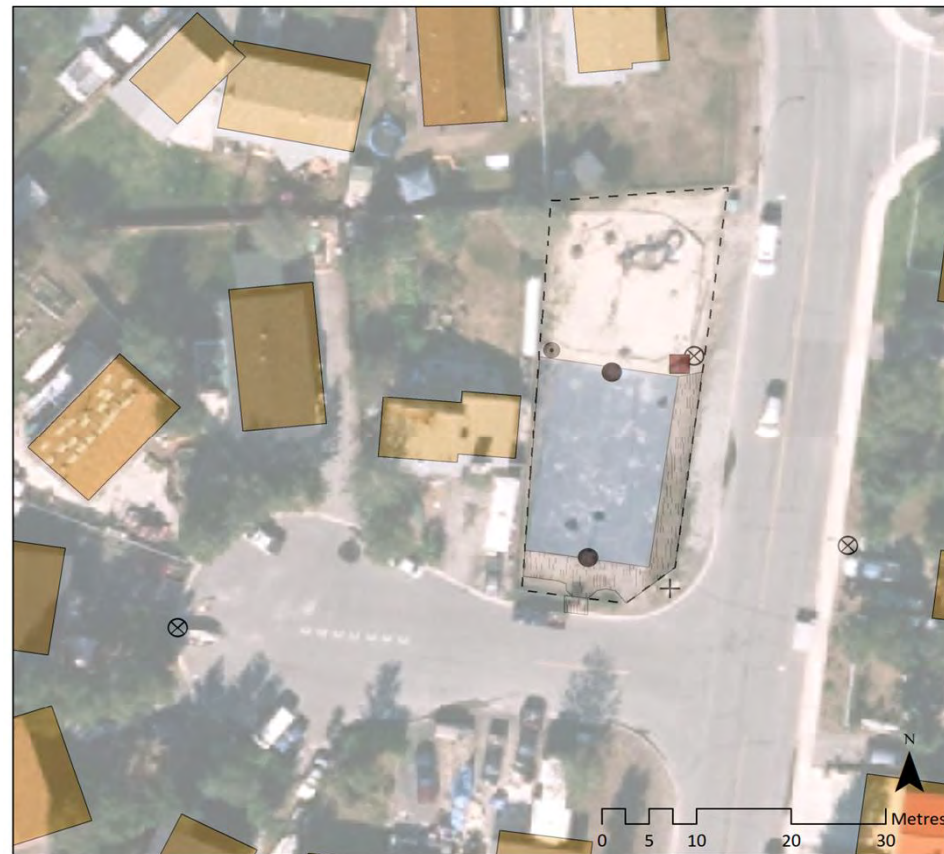
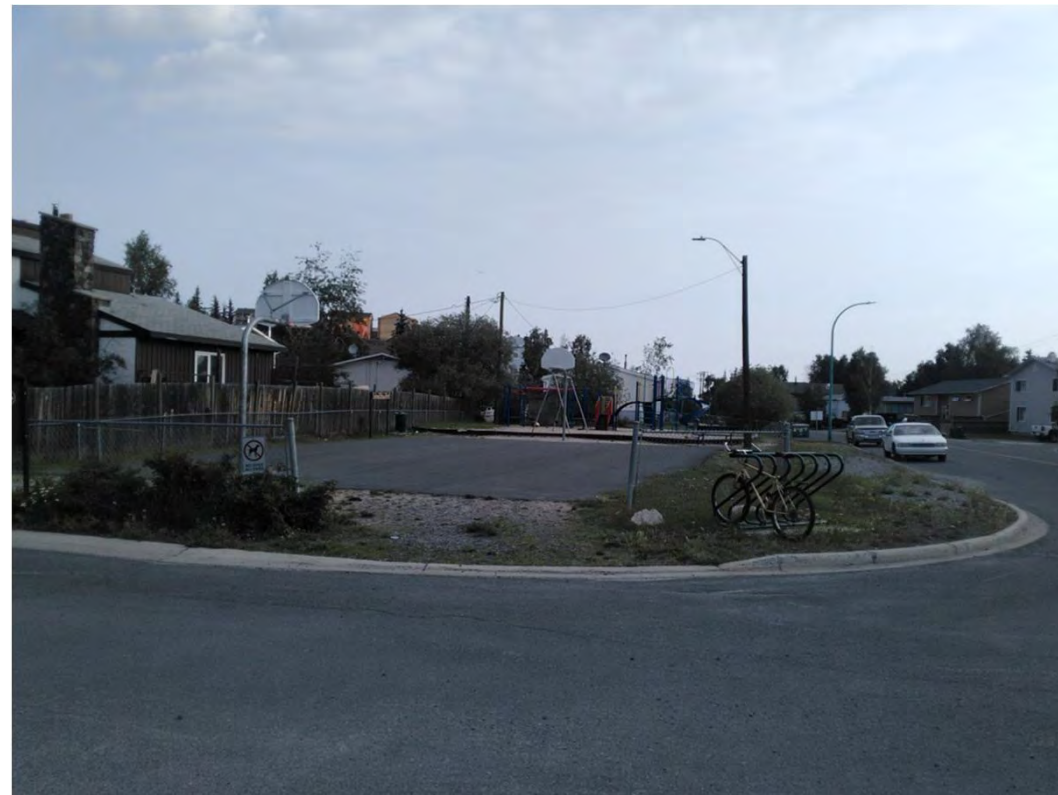
sidewalk curb incorporate ramp but route to paved court is rough and overgrown

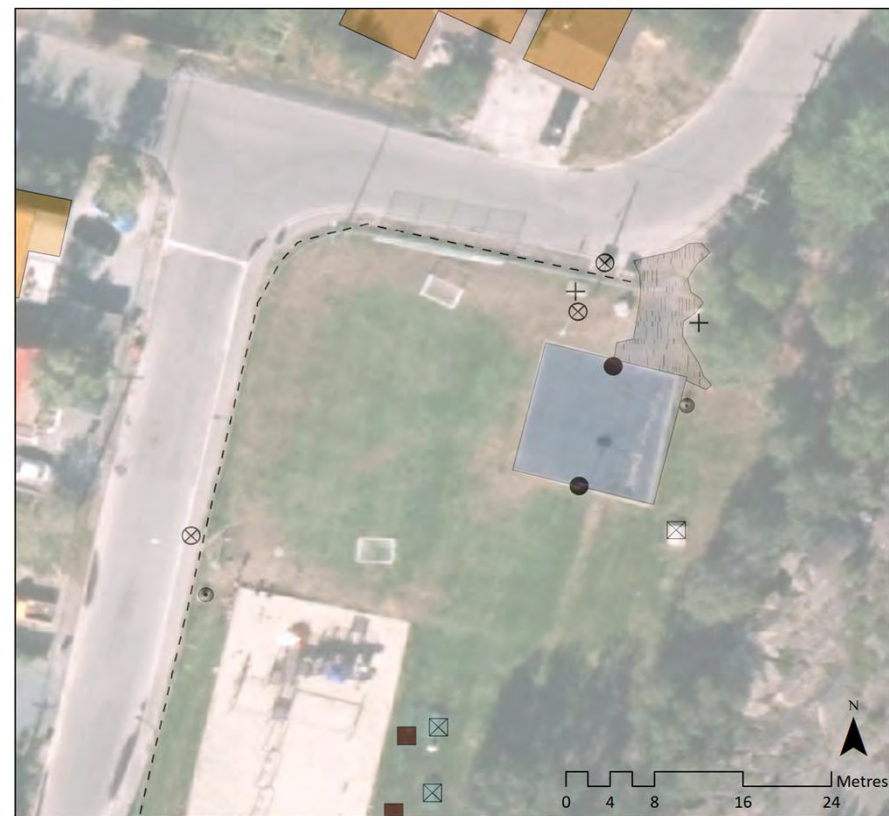
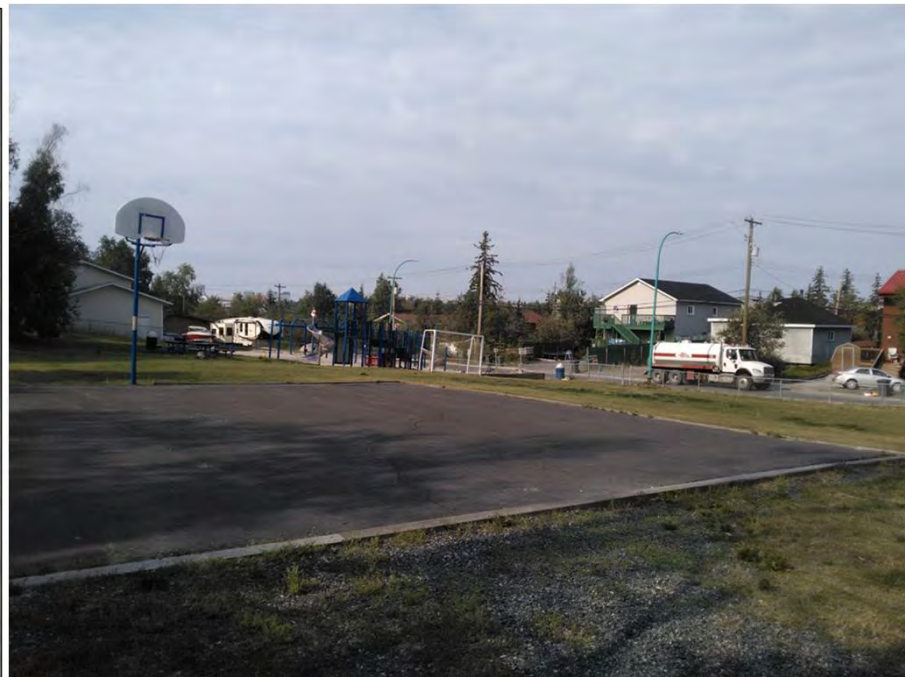
view of basketball court from north entry

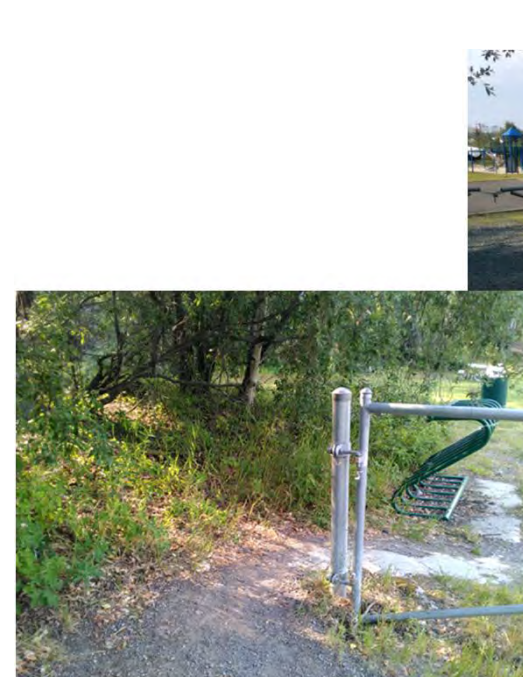
vehicle access gate
 pedestrians have worn a pathway to the left of the vehicle barrier

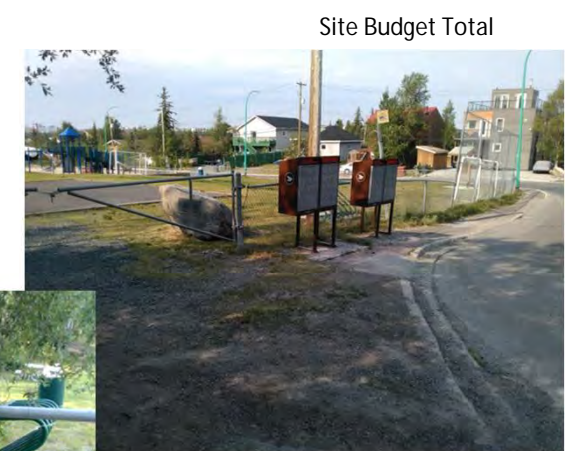
Site Budget Total \$20,300

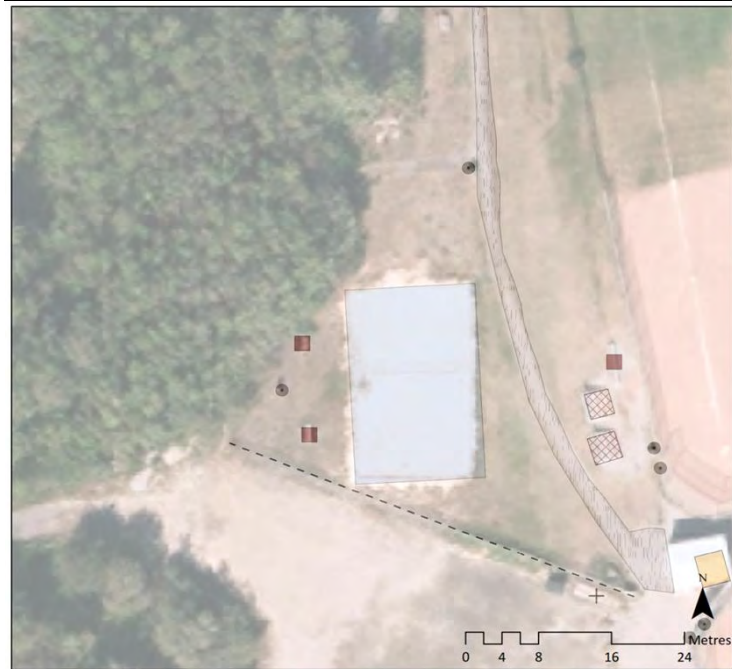
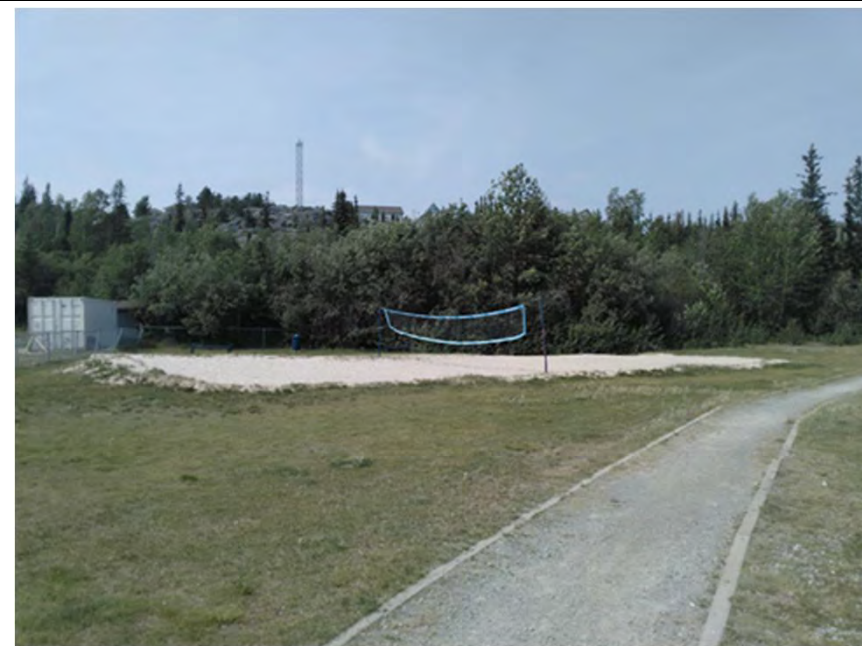
Site: 8. Sombe K'e Volleyball Court
 Audit Date: 10-Jul-17
 Auditor: Beth Cowan

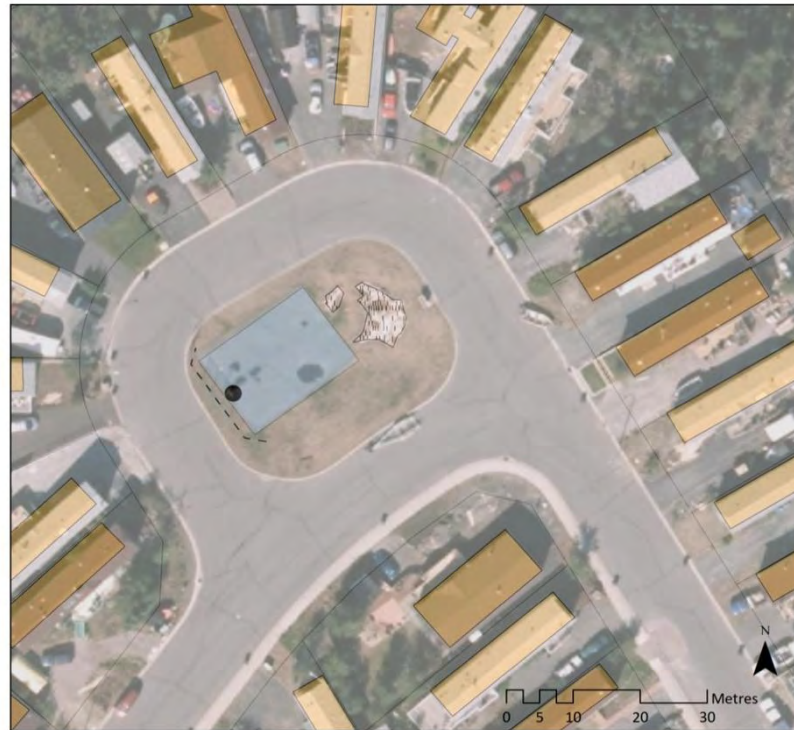
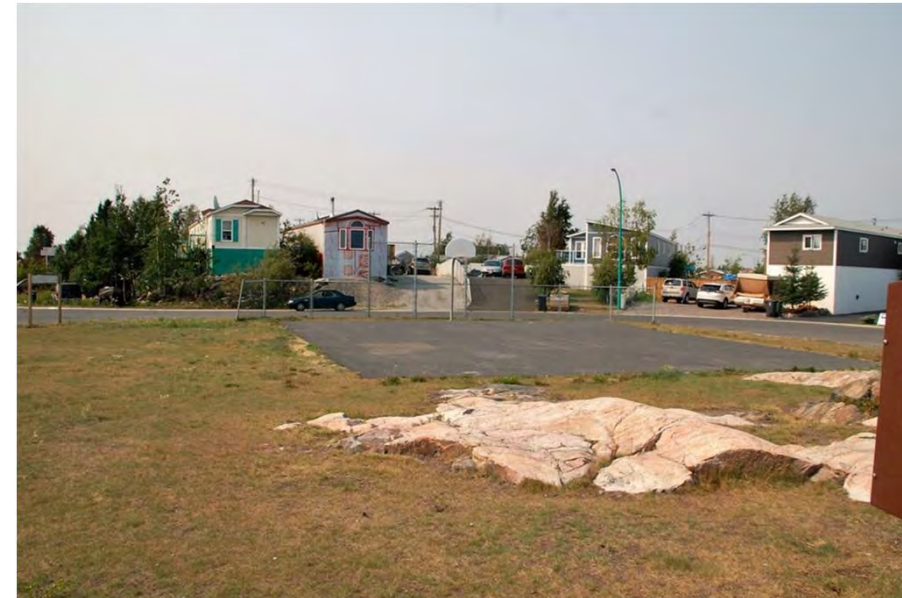
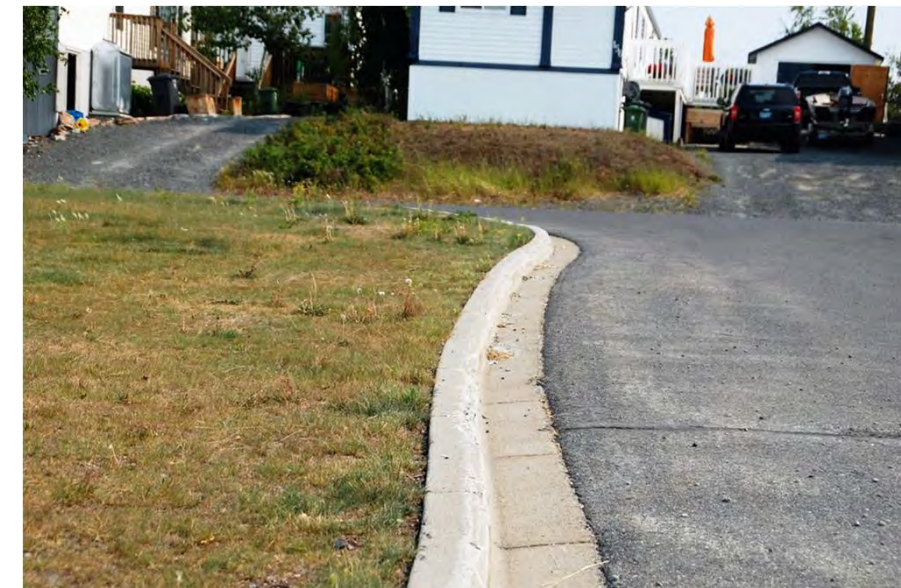
sports court 'island' is surrounded by raised curbs

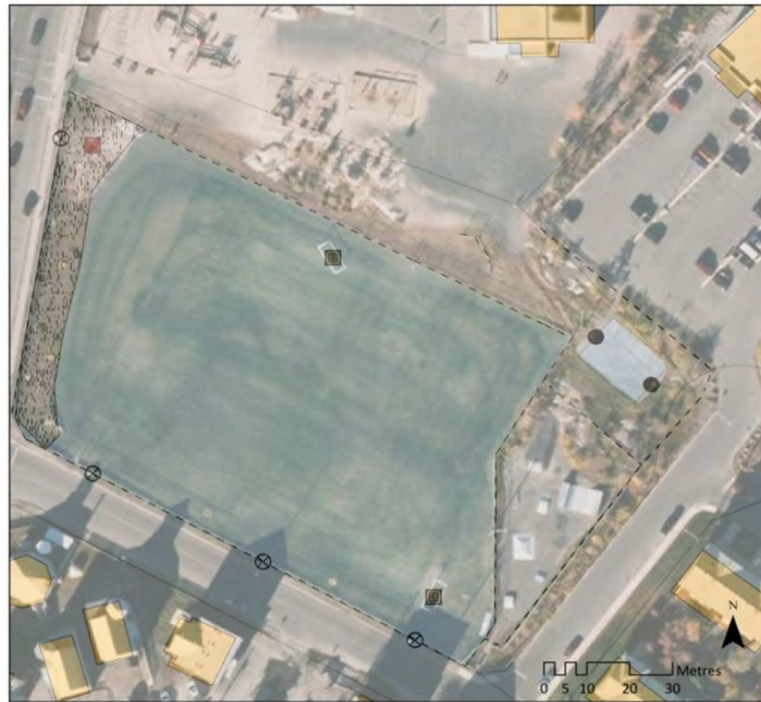
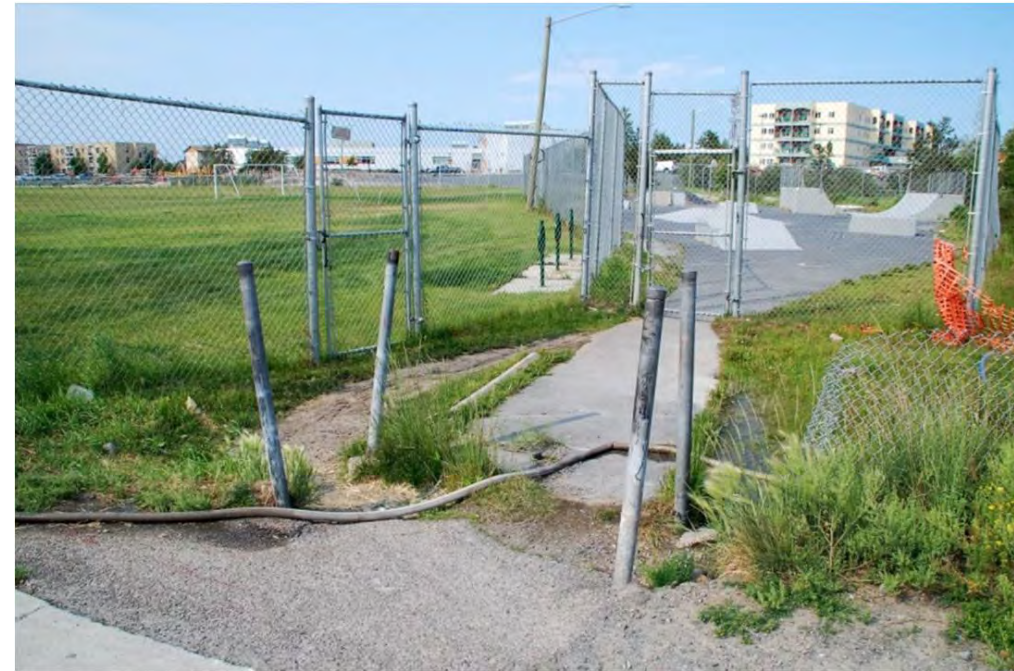
SE Entrance to sports field
